# **Tree Safety Survey Report.**

## **Horsmonden Parish Council.**

**Kieran Gorman & David Levett *MIC For, RFS Dip Arb, MArborA***

**September & October 2026.**

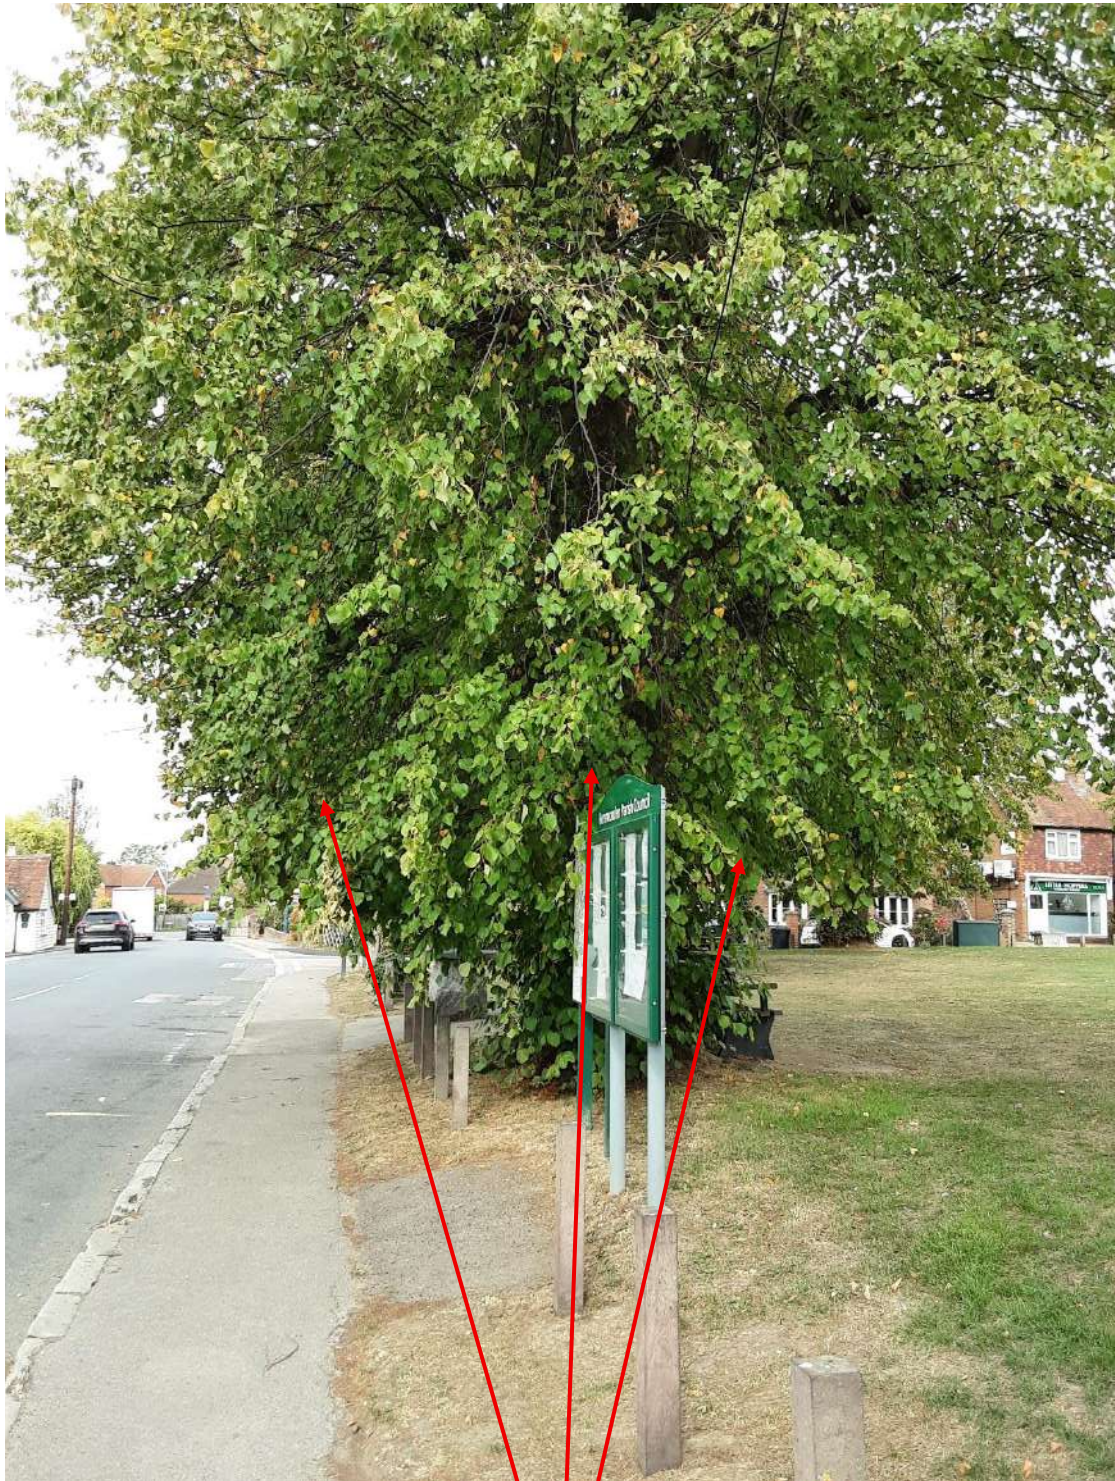
### 0227 – Common Lime

Low branches overhanging public footpath, notice board, and memorial bench.

| Tree Ref | Species | H (m) | Spr (m) | Maturity | Condition | Action Recommendations | Costs | Priority | Done | Inspected |
|---|---|---|---|---|---|---|---|---|---|---|
| 0227 | Common Lime | 12 | 4 | M | Good | Raise low canopy :: To 3.0m | £166.90 | 3 Months | No | 28-Sep-26 |
| Comment: Low branches overhanging public footpath, notice board, and memorial bench.<br>Raise low canopy to give a 3m clearance above ground level. | | | | | | | | | | |

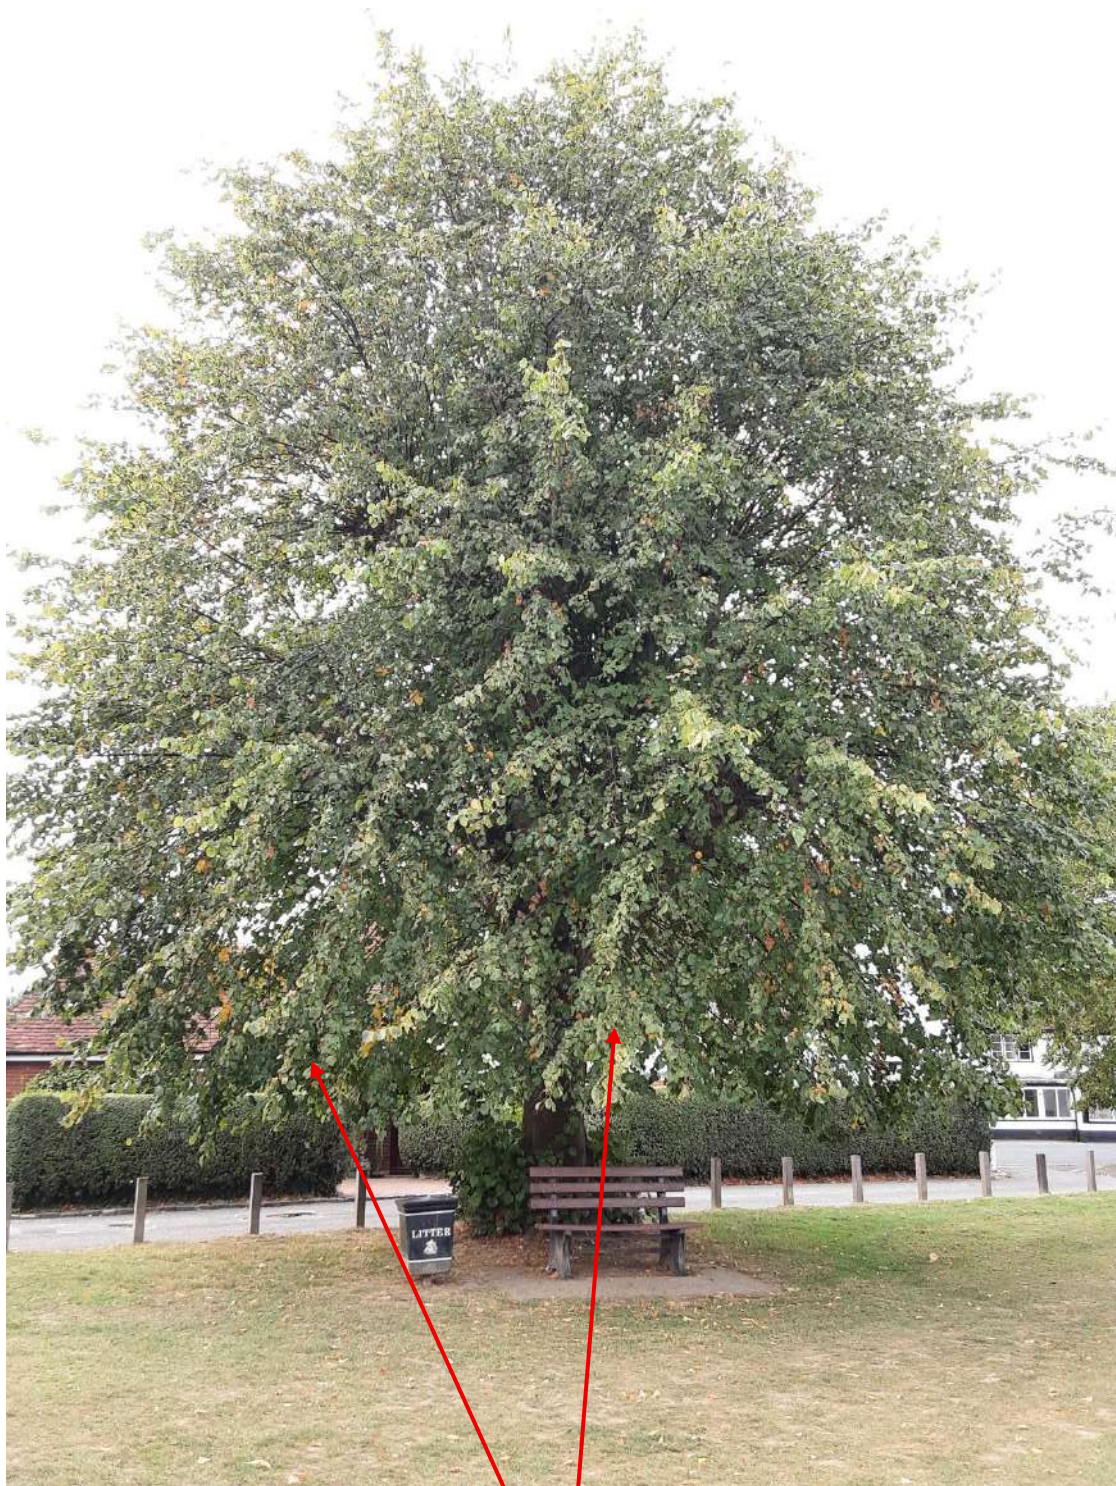
**0280 – Common Lime**

Low branches overhanging road and memorial bench.

| Tree Ref | Species | H (m) | Spr (m) | Maturity | Condition | Action Recommendations | Costs | Priority | Done | Inspected |
|---|---|---|---|---|---|---|---|---|---|---|
| 0280 | Common Lime | 12 | 5 | M | Good | Raise low canopy :: To 3.0m | £111.25 | 3 Months | No | 28-Sep-26 |
| Comment: Low branches overhanging road and memorial bench.<br>Raise low branches to give 3m clearance above ground level. | | | | | | | | | | |

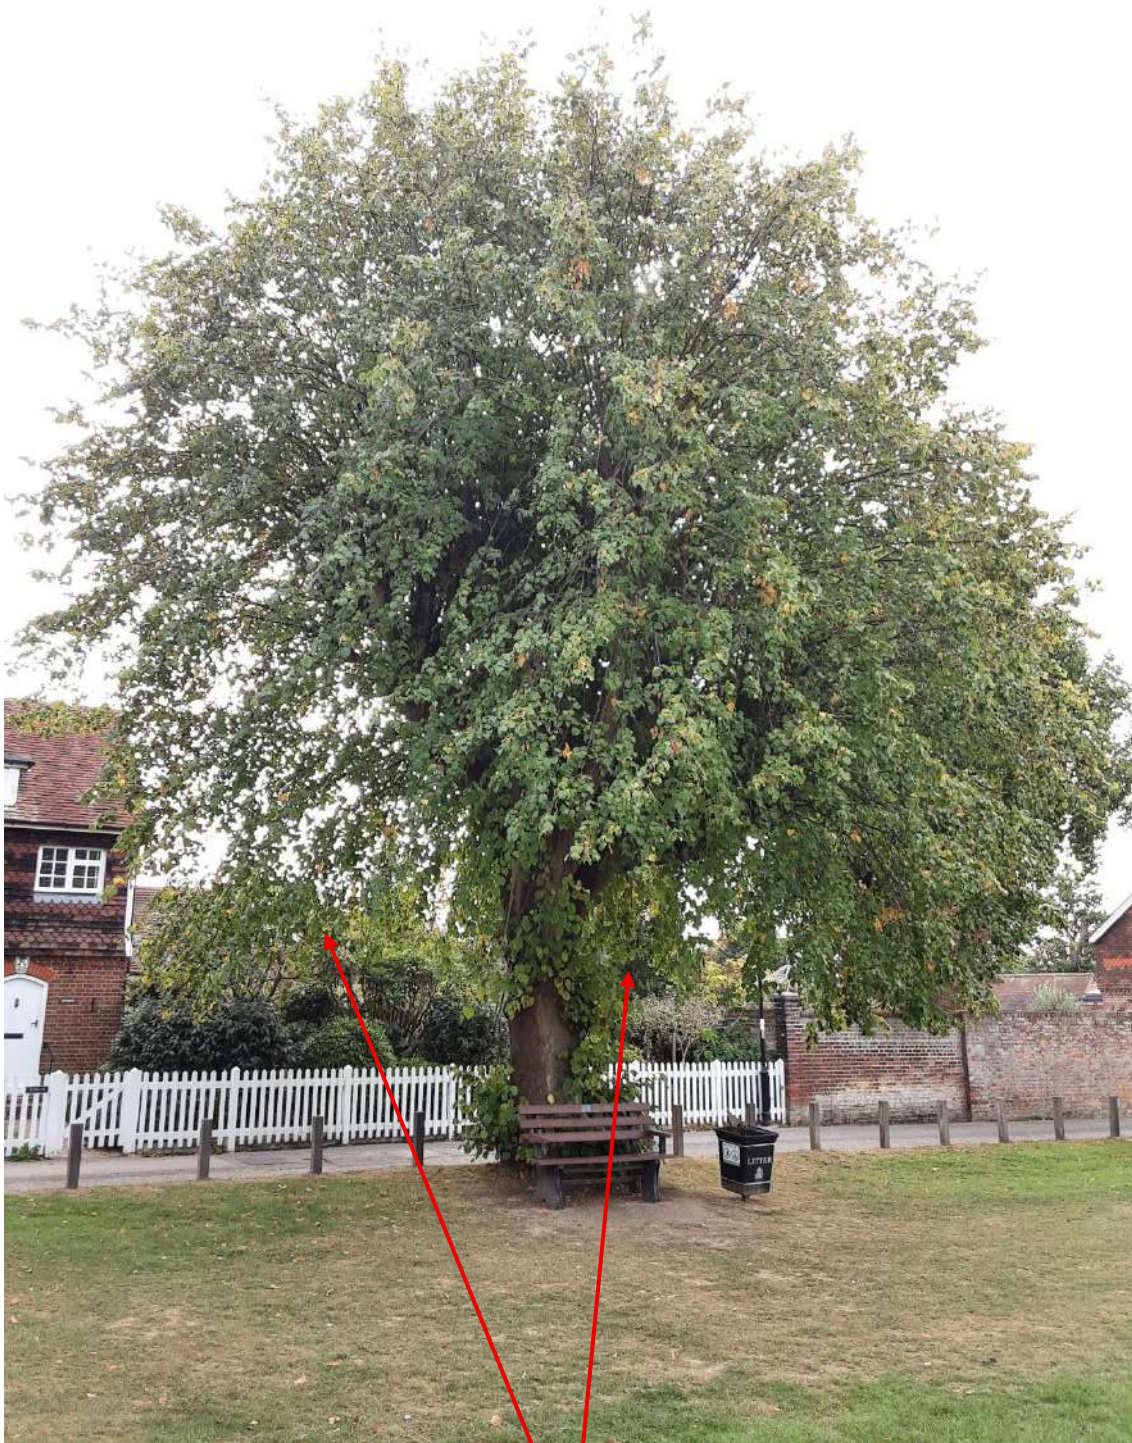
**0281 – Common Lime**

Low branches overhanging road and memorial bench.

| Tree Ref | Species | H (m) | Spr (m) | Maturity | Condition | Action Recommendations | Costs | Priority | Done | Inspected |
|---|---|---|---|---|---|---|---|---|---|---|
| 0281 | Common Lime | 11 | 4 | M | Good | Raise low canopy :: To 3.0m | £166.90 | 3 Months | No | 28-Sep-26 |
| Comment: Low branches overhanging road and memorial bench.<br>Raise low branches to give 3m clearance above ground level. | | | | | | | | | | |

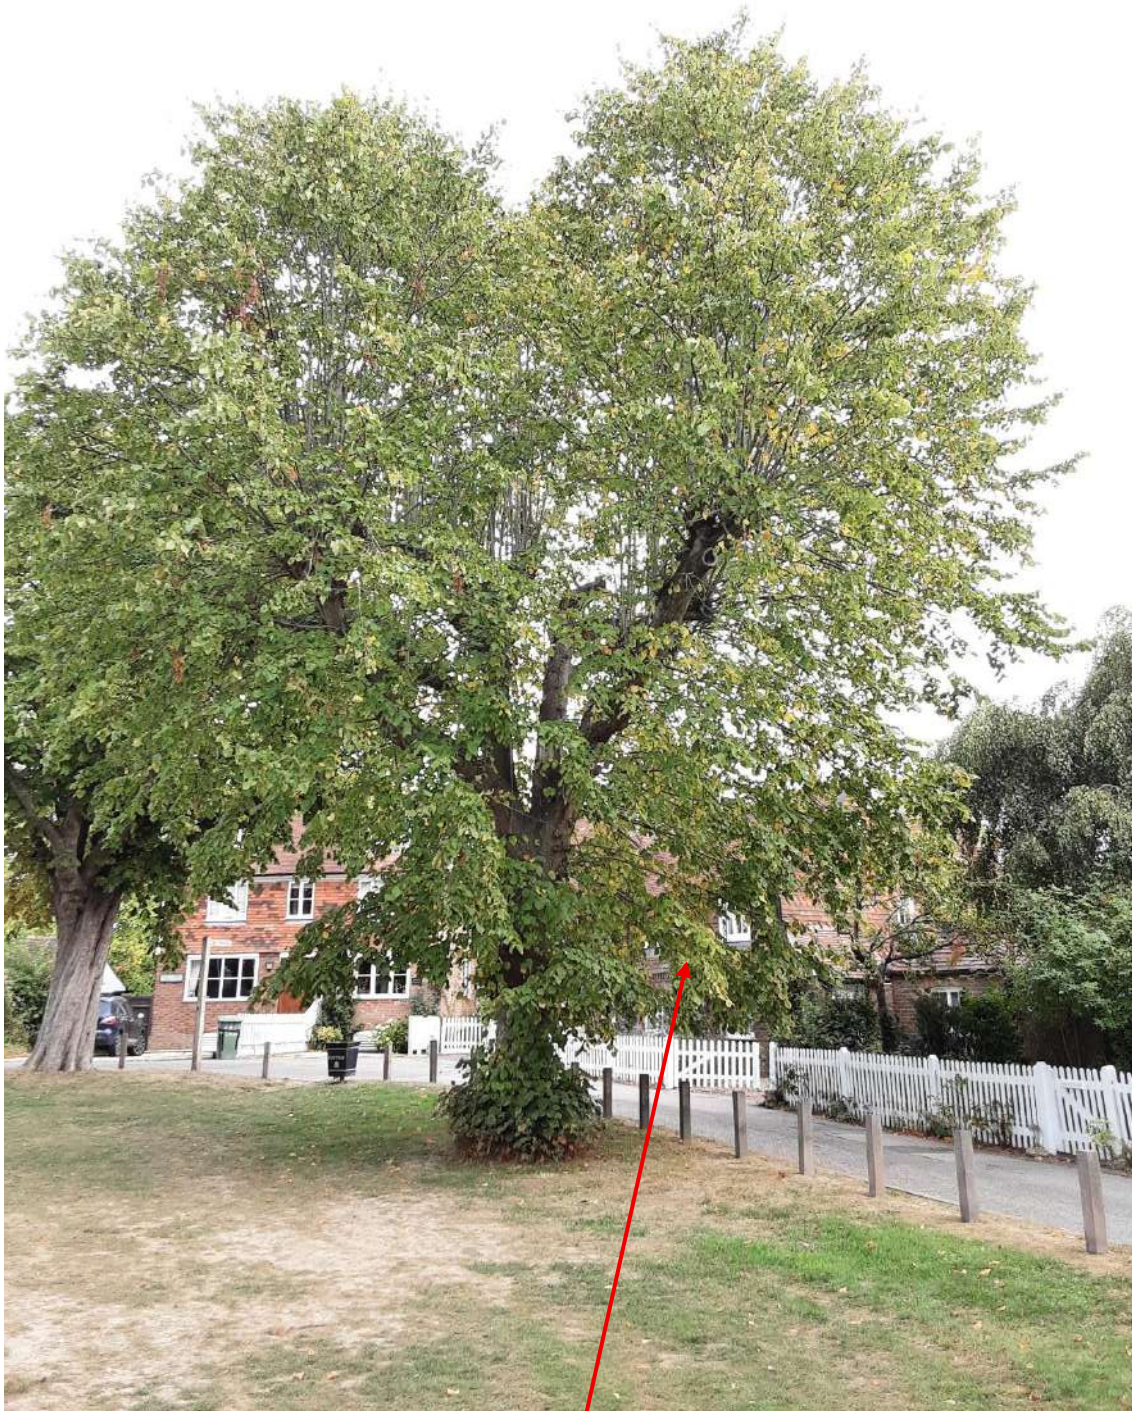
**0282 – Common Lime**

Low branches overhanging road.

| Tree Ref | Species | H (m) | Spr (m) | Maturity | Condition | Action Recommendations | Costs | Priority | Done | Inspected |
|---|---|---|---|---|---|---|---|---|---|---|
| 0282 | Common Lime | 11 | 4 | M | Good | Raise low canopy :: To 3.0m | £111.25 | 3 Months | No | 28-Sep-26 |
| Comment: Low branches overhanging road.<br>Raise low branches to give 3m clearance above ground level. | | | | | | | | | | |

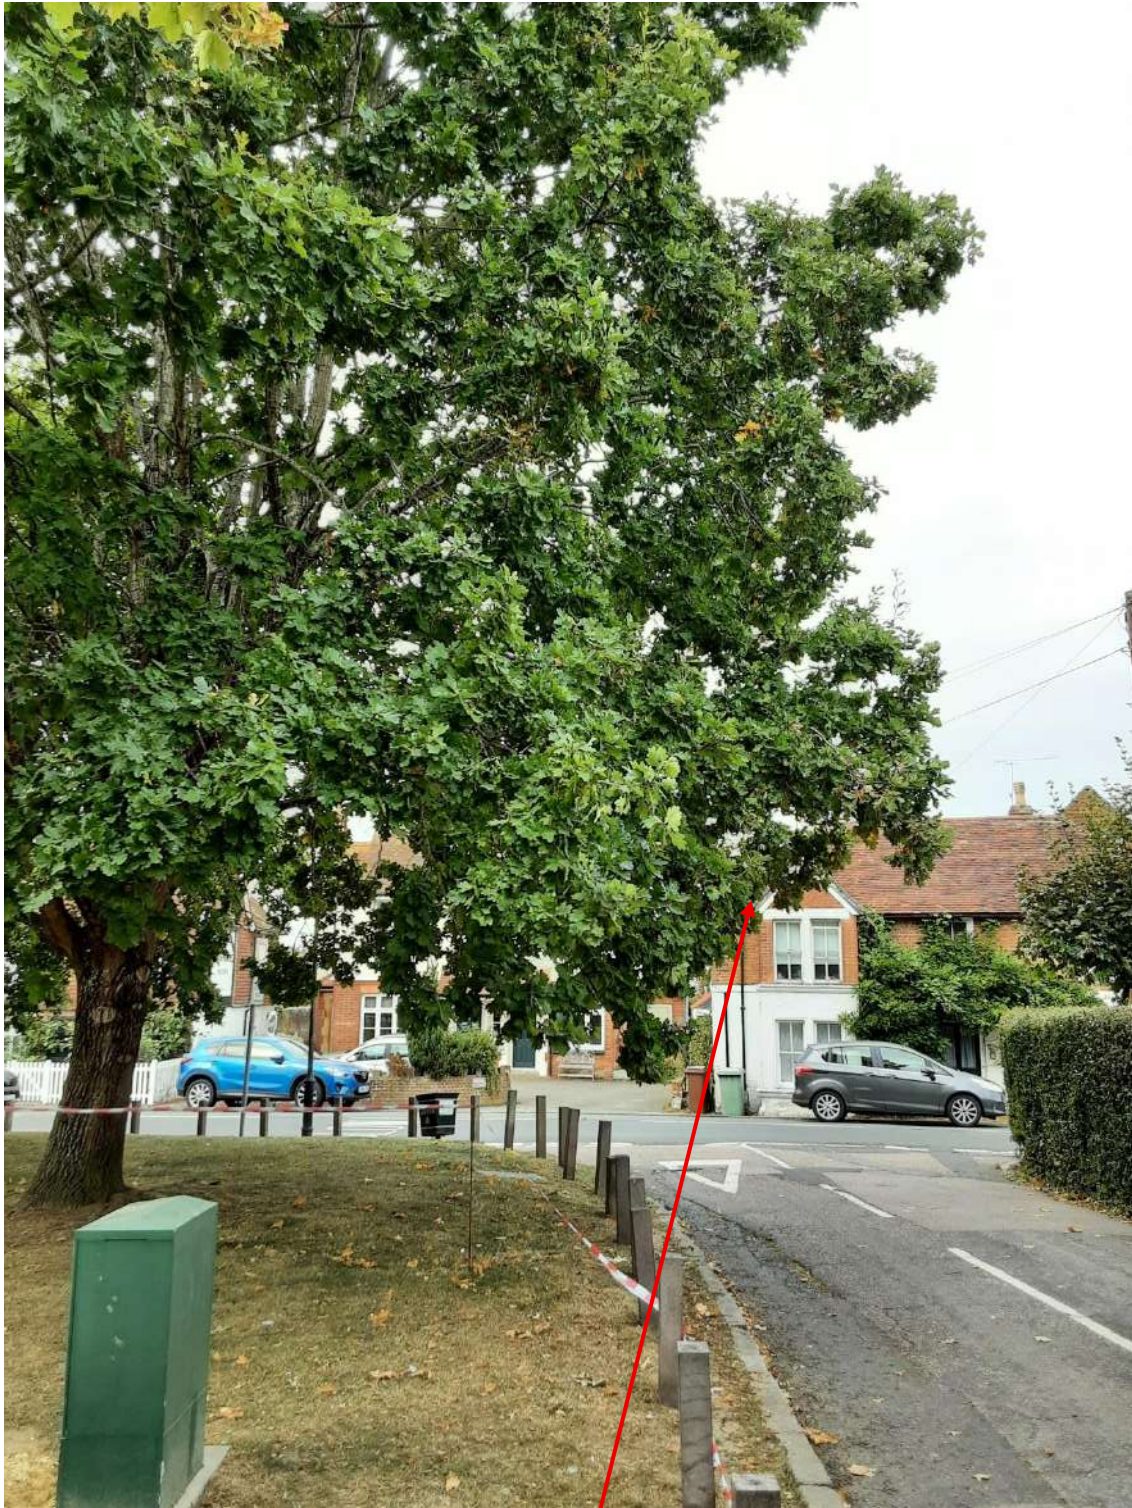
**0287 – Common Oak**

Low branches overhanging road.

| Tree Ref | Species | H (m) | Spr (m) | Maturity | Condition | Action Recommendations | Costs | Priority | Done | Inspected |
|---|---|---|---|---|---|---|---|---|---|---|
| 0287 | Common Oak | 12 | 6 | SM | Good | Raise low canopy :: To 3.0m | £111.25 | 6 Months | No | 28-Sep-26 |
| Comment: Low branches overhanging road.<br>Raise low branches overhanging road to give 3m clearance above ground level. | | | | | | | | | | |

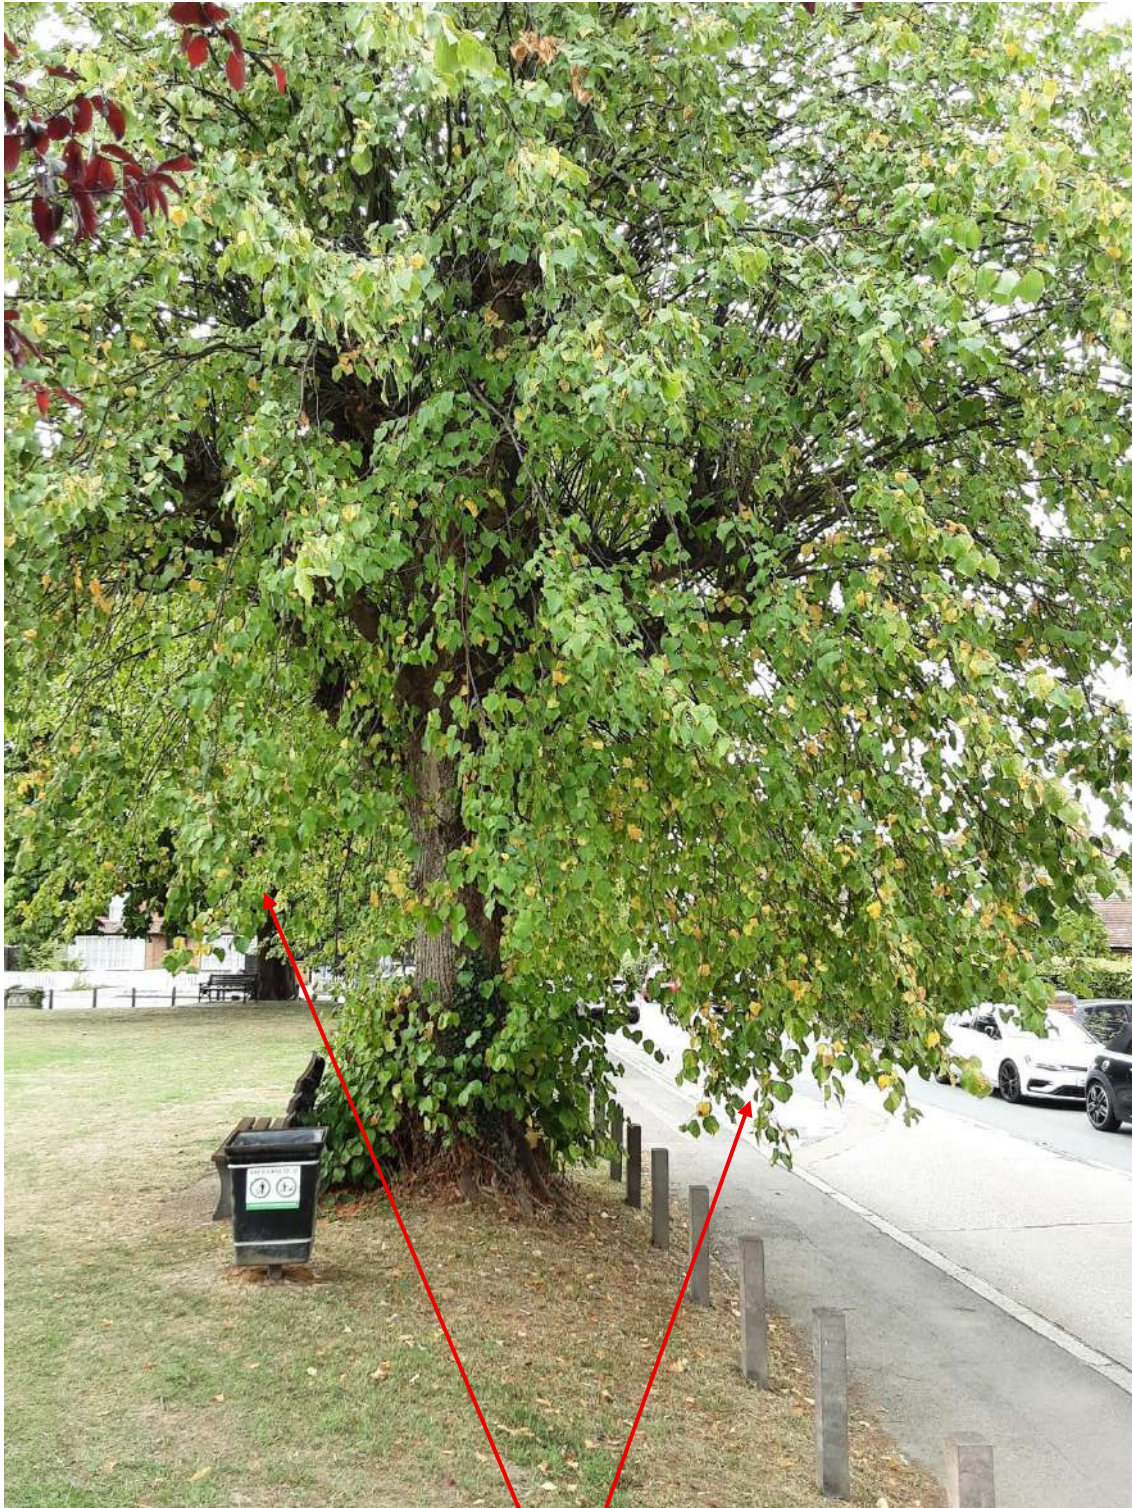
**0291 – Common Lime**

Low branches overhanging public footpath and memorial bench.

| Tree Ref | Species | H (m) | Spr (m) | Maturity | Condition | Action Recommendations | Costs | Priority | Done | Inspected |
|---|---|---|---|---|---|---|---|---|---|---|
| 0291 | Common Lime | 11 | 4 | M | Good | Raise low canopy :: To 3.0m | £166.90 | 3 Months | No | 28-Sep-26 |
| Comment: Low branches overhanging public footpath and memorial bench.<br>Raise low branches to give a 3m clearance above ground level. | | | | | | | | | | |

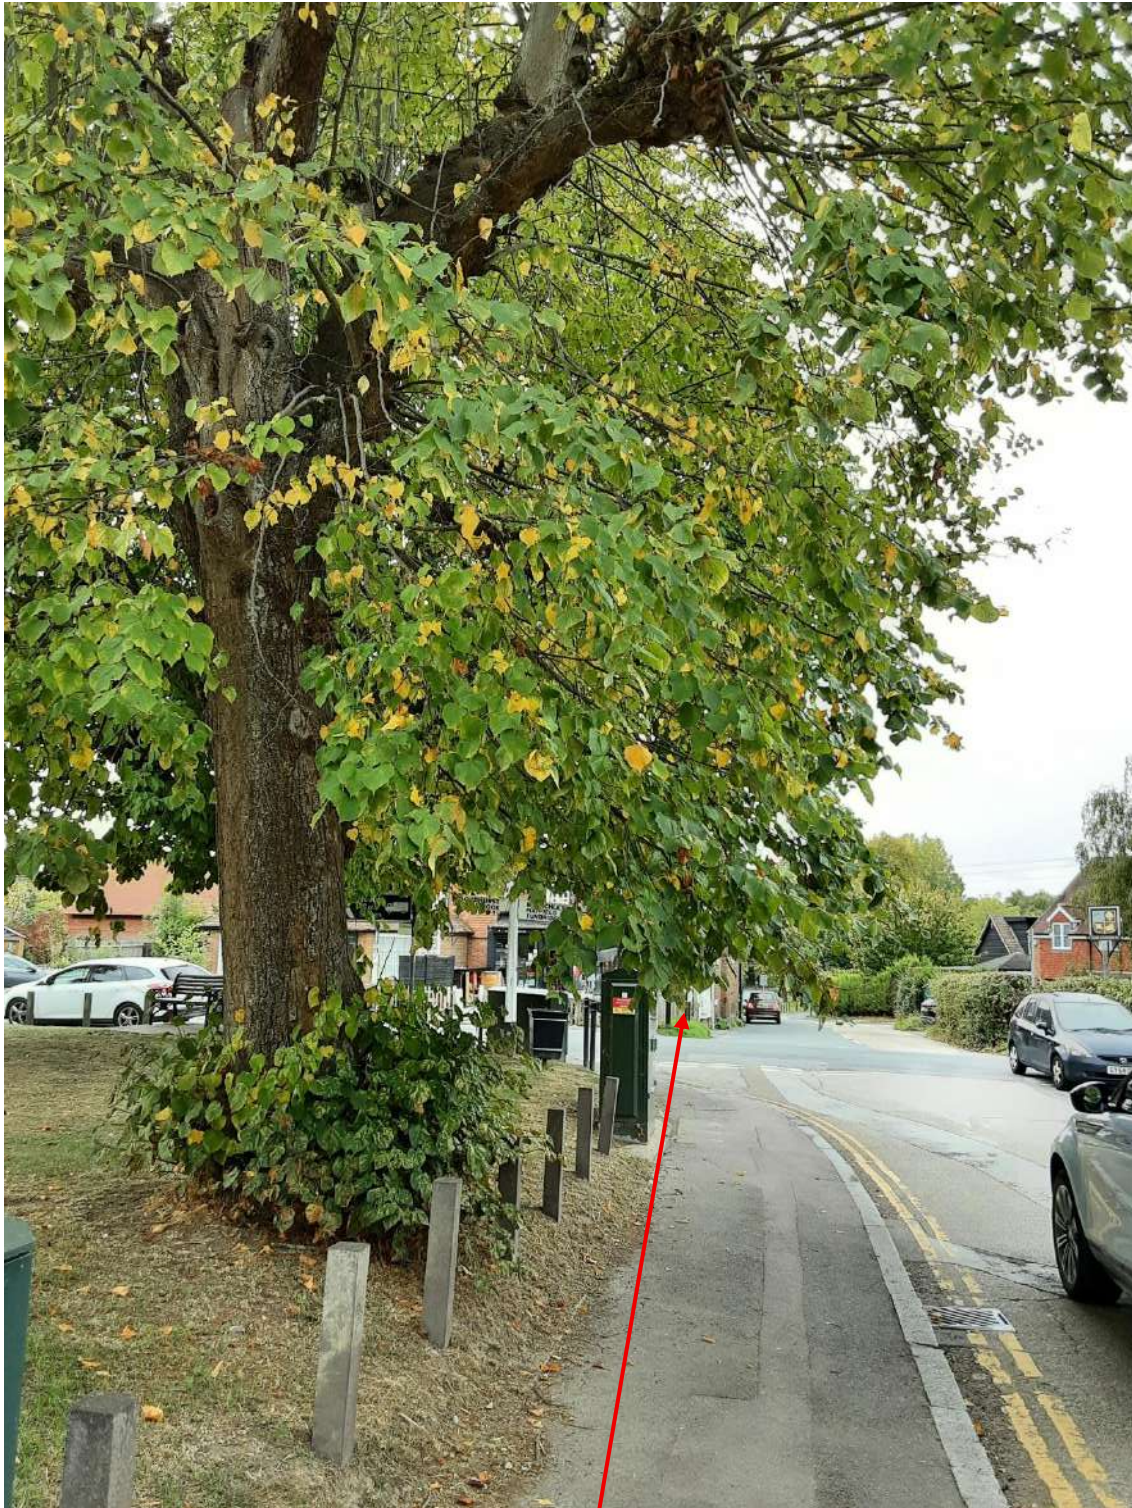
## 0292 – Common Lime

Low branches overhanging public footpath.

| Tree Ref | Species | H (m) | Spr (m) | Maturity | Condition | Action Recommendations | Costs | Priority | Done | Inspected |
|---|---|---|---|---|---|---|---|---|---|---|
| 0292 | Common Lime | 10 | 4 | M | Good | Raise low canopy :: To 3.0m | £111.25 | 3 Months | No | 28-Sep-26 |
| Comment: Low branches overhanging public footpath.<br>Raise low branches overhanging public footpath to give 3m clearance above ground level. | | | | | | | | | | |

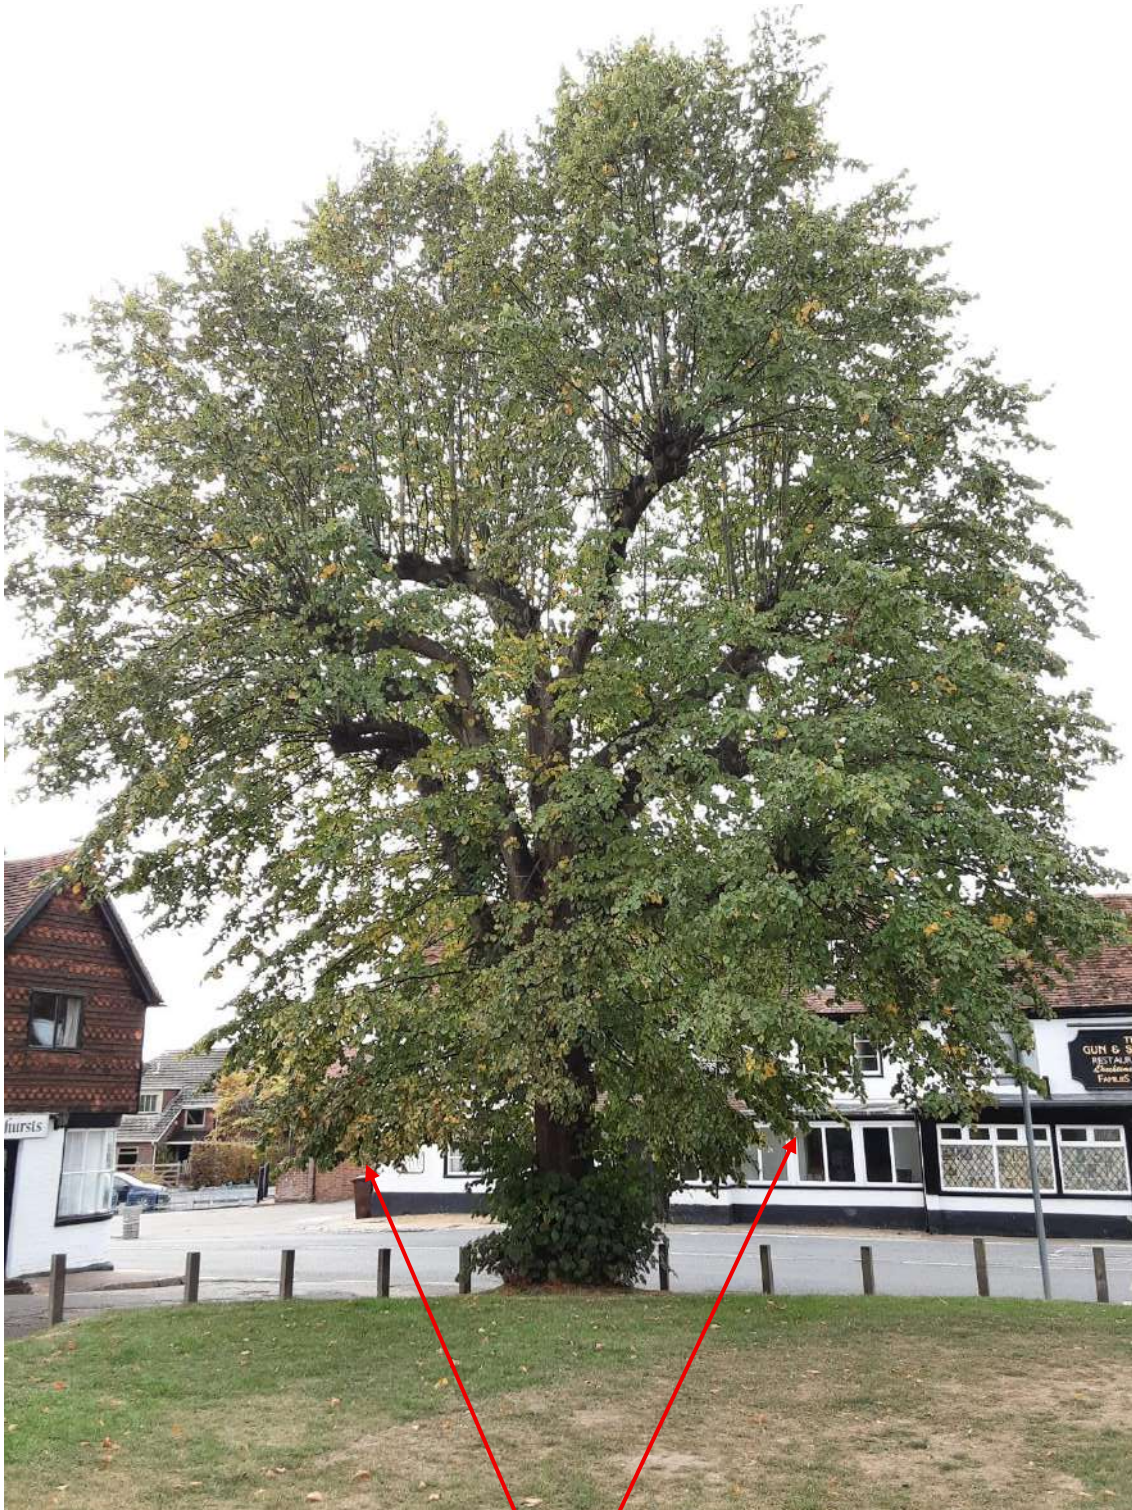
**3196 – Common Lime**

Low branches overhanging public footpath and edge of road.

| Tree Ref | Species | H (m) | Spr (m) | Maturity | Condition | Action Recommendations | Costs | Priority | Done | Inspected |
|---|---|---|---|---|---|---|---|---|---|---|
| 3196 | Common Lime | 11 | 5 | M | Good | Raise low canopy :: To 3.0m | £166.90 | 3 Months | No | 28-Sep-26 |
| Comment: Low branches overhanging public footpath and edge of road.<br>Raise low branches to give a 3m clearance above ground level. | | | | | | | | | | |

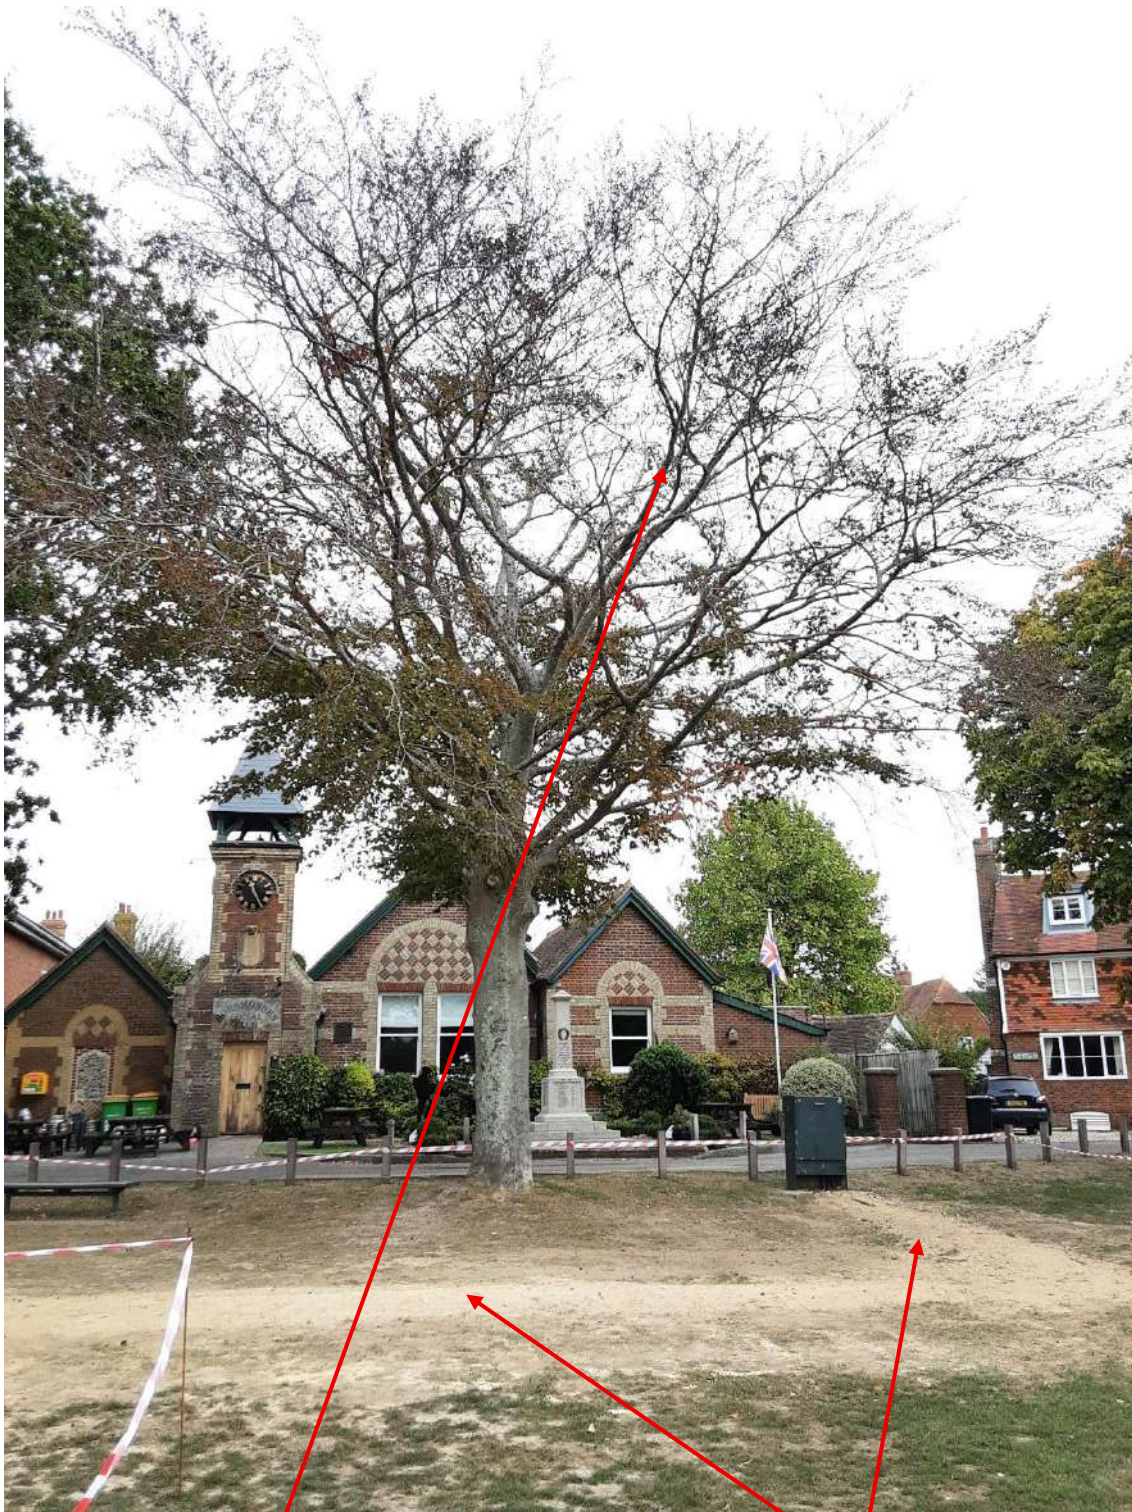
### 3198 – Common Beech

Tree in decline with significant dieback of crown and major deadwood present.

Recent trenching works undertaken for underground services to new junction box, resulting in root severance on southern and eastern sides.

| Tree Ref | Species | H (m) | Spr (m) | Maturity | Condition | Action Recommendations | Costs | Priority | Done | Inspected |
|---|---|---|---|---|---|---|---|---|---|---|
| 3198 | Common Beech | 13 | 6 | M | Poor | Re-inspect :: See Comment<br>Remove :: Major dead wood | £222.50 | 1 year<br>3 Months | No<br>No | 28-Sep-26 |
| Comment: Tree in decline with significant dieback of crown and major deadwood present.<br>Recent trenching works undertaken for underground services to new junction box, resulting in the severance of several roots on the southern and eastern sides and likely to cause further decline in overall health of tree.<br>Remove major deadwood from crown.<br>Re-inspect tree in summer 2027 to monitor health of tree. | | | | | | | | | | |

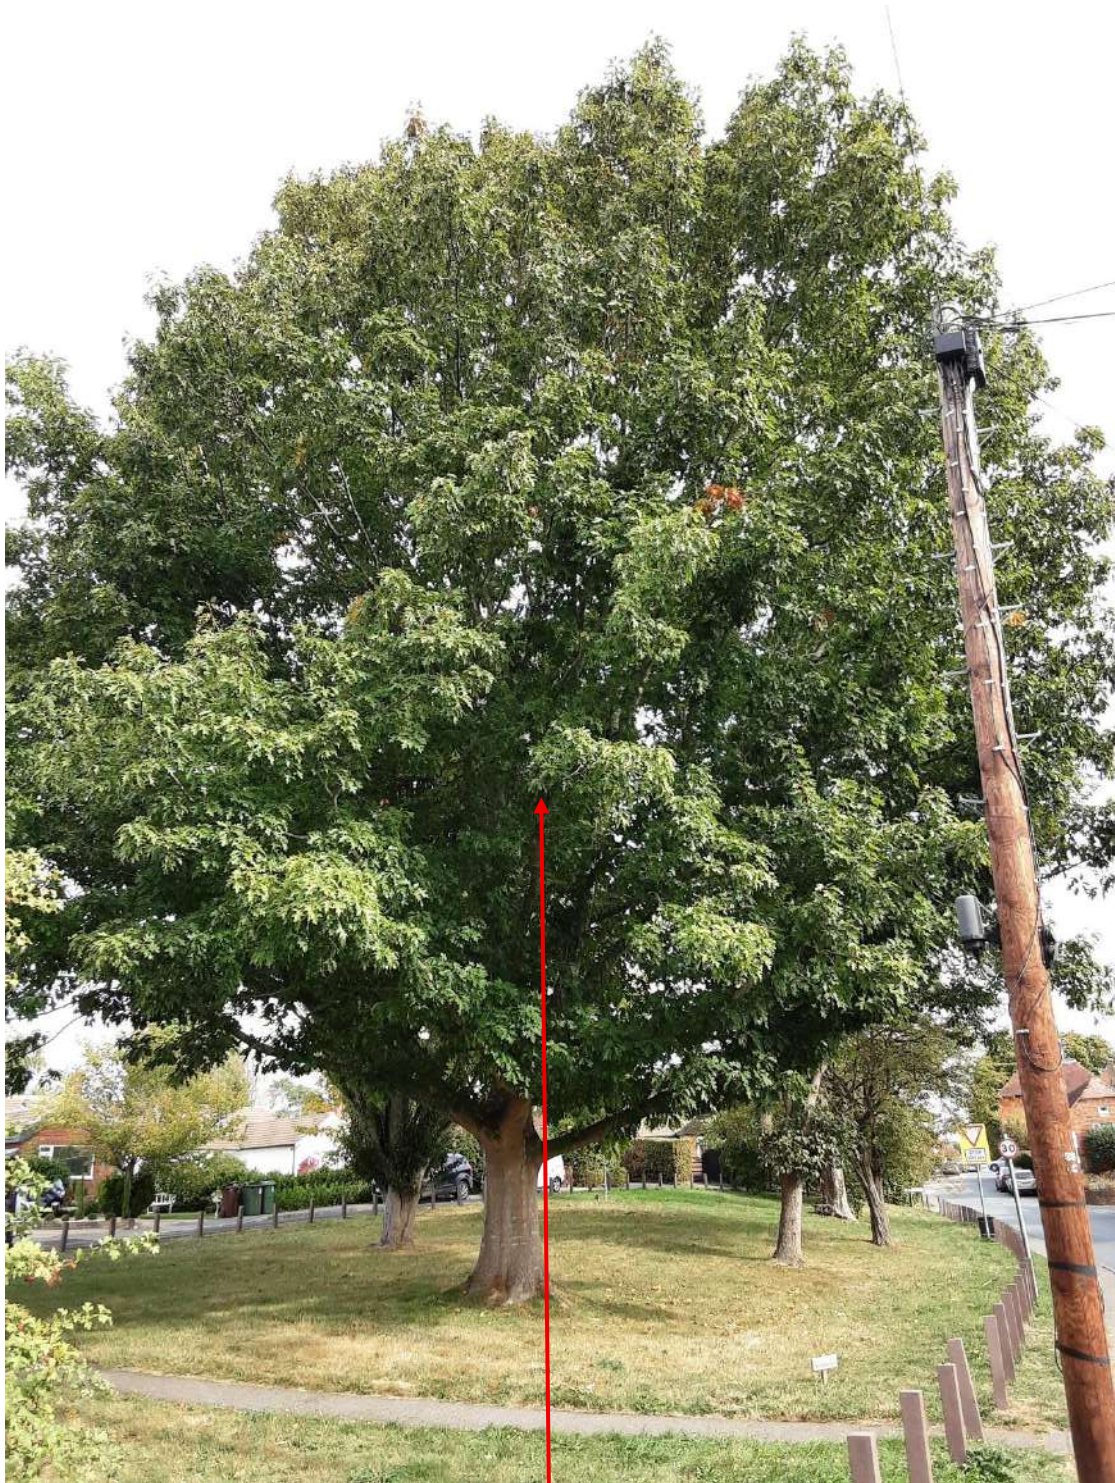
0014 – Red Oak

Dense crown shading ground, impeding development of wild flower meadow.

| Tree Ref | Species | H (m) | Spr (m) | Maturity | Condition | Action Recommendations | Costs | Priority | Done | Inspected |
|---|---|---|---|---|---|---|---|---|---|---|
| 0014 | Red Oak | 18 | 7 | M | Good | Thin crown(s) :: By 20 - 25% | £1,190.00 | 1 year | No | 28-Sep-26 |
| Comment: Thin crown by approximately 25%.<br>(Management works to encourage the development of wild flower meadow). | | | | | | | | | | |

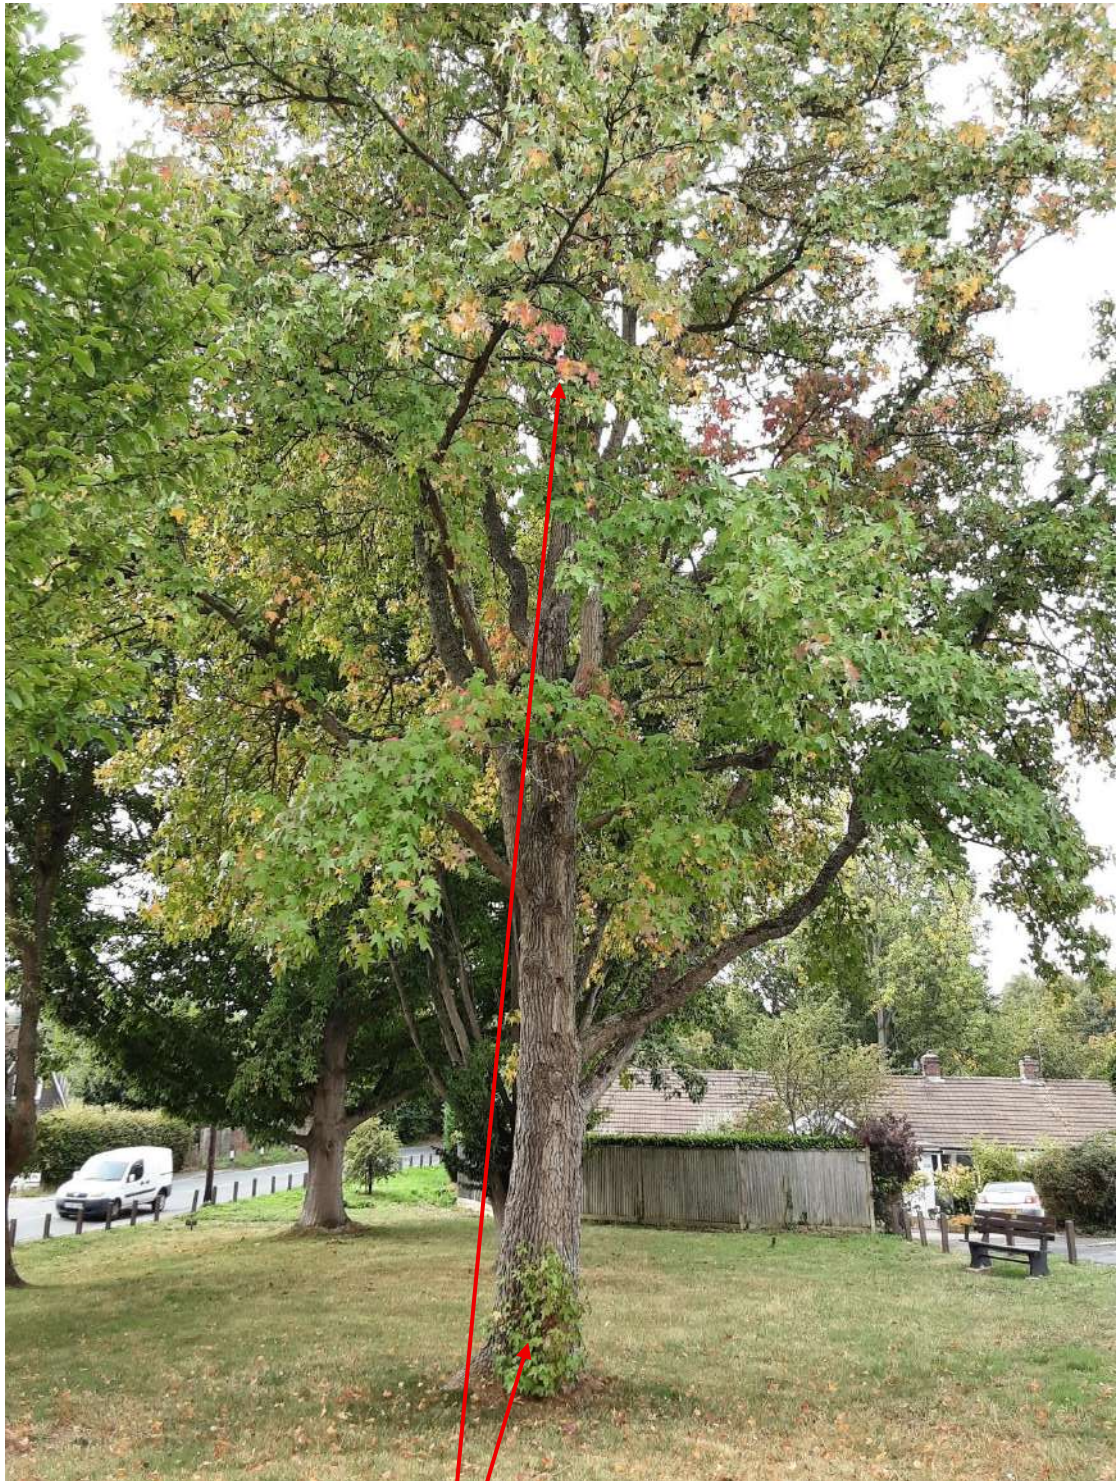
0295 – Sweetgum

Crown and epicormic growth at base shading ground, impeding development of wild flower meadow.

| Tree Ref | Species | H (m) | Spr (m) | Maturity | Condition | Action Recommendations | Costs | Priority | Done | Inspected |
|---|---|---|---|---|---|---|---|---|---|---|
| 0295 | Sweetgum | 17 | 4 | M | Good | See Comment :: See Comment | £222.50 | 6 Months | No | 28-Sep-26 |
| Comment: Crown raise to a height of approximately 6m, by removing smaller lateral branches.<br>Remove epicormic growth at base of main stem.<br>(Management works to encourage the development of wild flower meadow). | | | | | | | | | | |

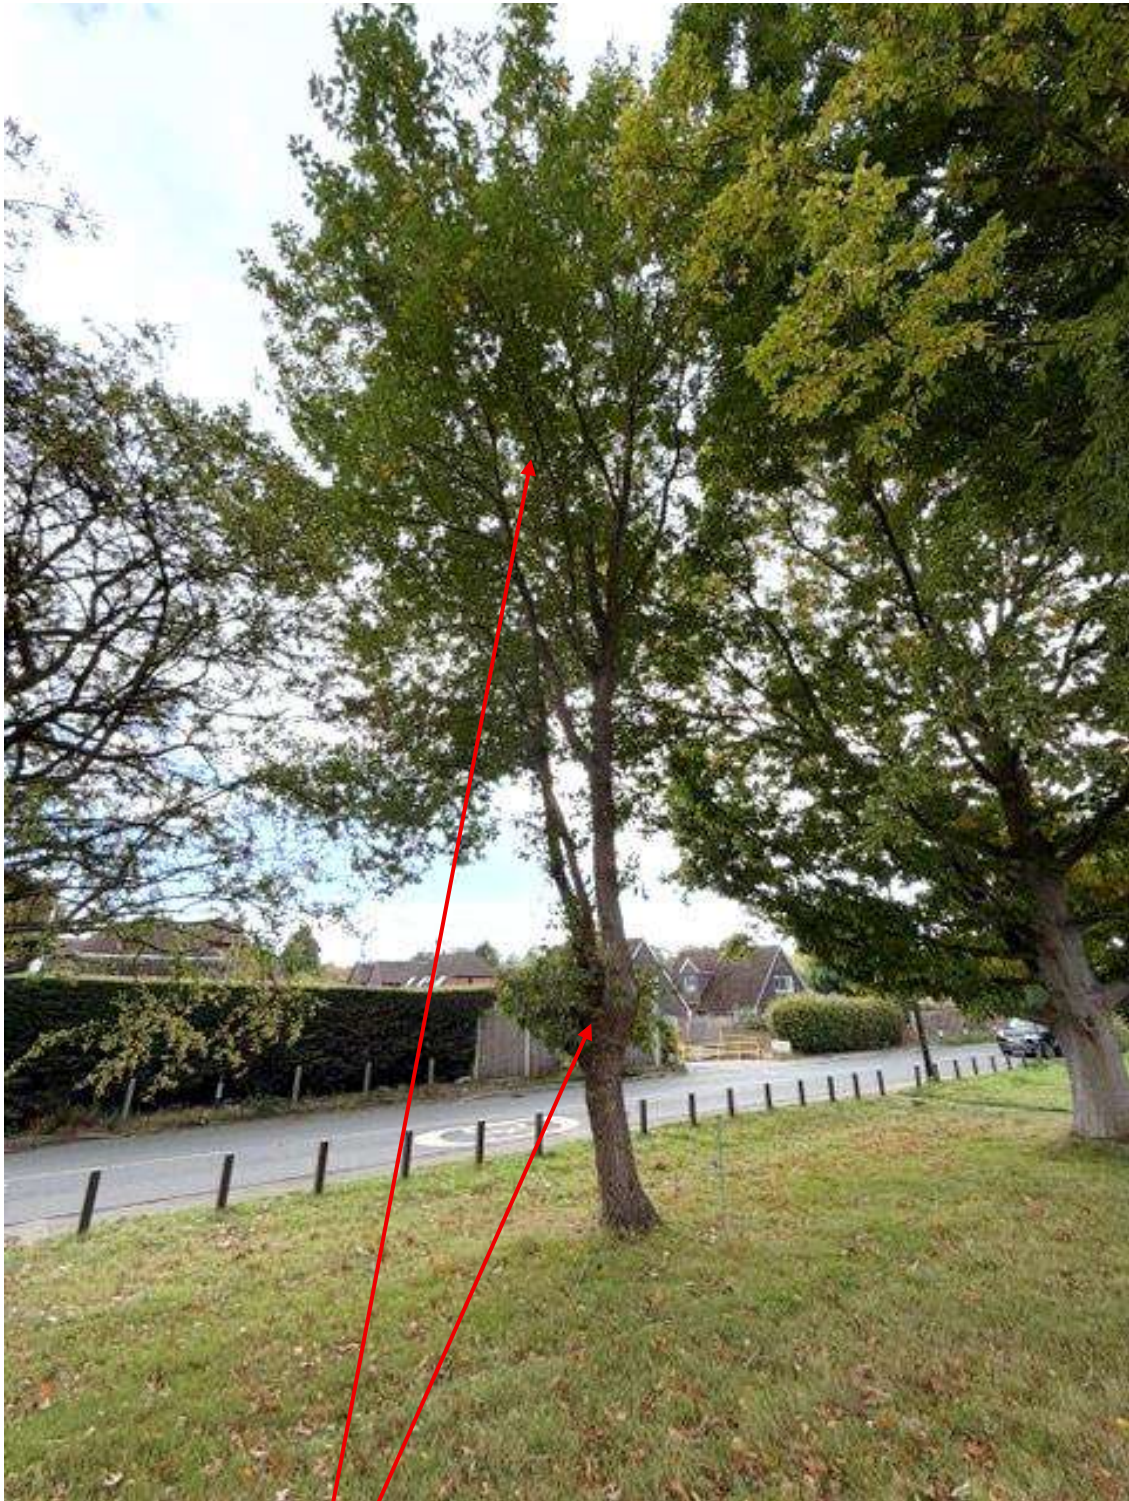
**0298 – Common Oak**

Crown and regrowth on old pruning wounds on main stem, up to a height of approximately 4m shading ground, impeding development of wild flower meadow.

| Tree Ref | Species | H (m) | Spr (m) | Maturity | Condition | Action Recommendations | Costs | Priority | Done | Inspected |
|---|---|---|---|---|---|---|---|---|---|---|
| 0298 | Common Oak | 14 | 4 | SM | Fair | See Comment :: See Comment | £278.15 | 1 year | No | 28-Sep-26 |
| Comment: Thin crown by approximately 25%.<br>Remove regrowth on old pruning wounds on main stem, up to a height of approximately 4m.<br>(Management works to encourage the development of wild flower meadow). | | | | | | | | | | |
