# **Tree Safety Survey Report.**

## **Horsmonden Parish Council.**

**Kieran Gorman & David Levett *MIC For, RFS Dip Arb, MArborA***

**September & October 2026.**

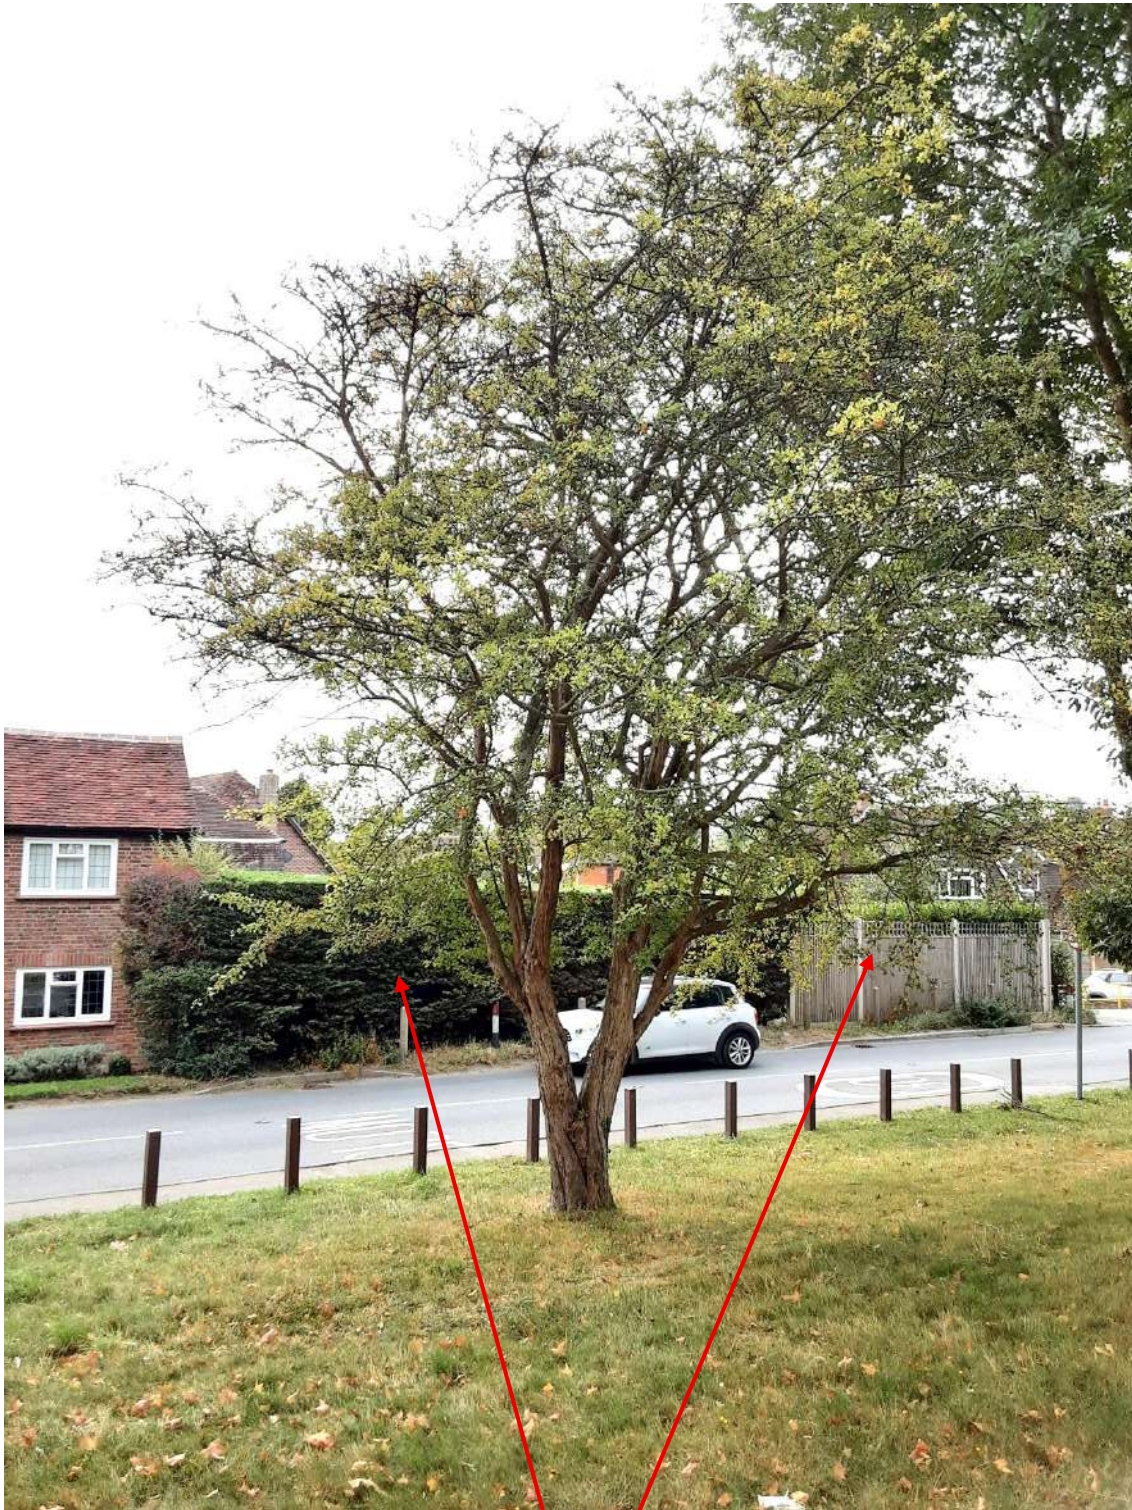
## 0299 – Common Hawthorn

Lower crown shading ground, impeding development of wild flower meadow.

| Tree Ref | Species | H (m) | Spr (m) | Maturity | Condition | Action Recommendations | Costs | Priority | Done | Inspected |
|---|---|---|---|---|---|---|---|---|---|---|
| 0299 | Common Hawthorn | 6 | 3 | M | Good | Raise low canopy :: To 3.0m | £222.50 | 1 year | No | 28-Sep-26 |
| Comment: Crown raise to give a clearance of 3m above ground level.<br>(Management works to encourage the development of wild flower meadow). | | | | | | | | | | |

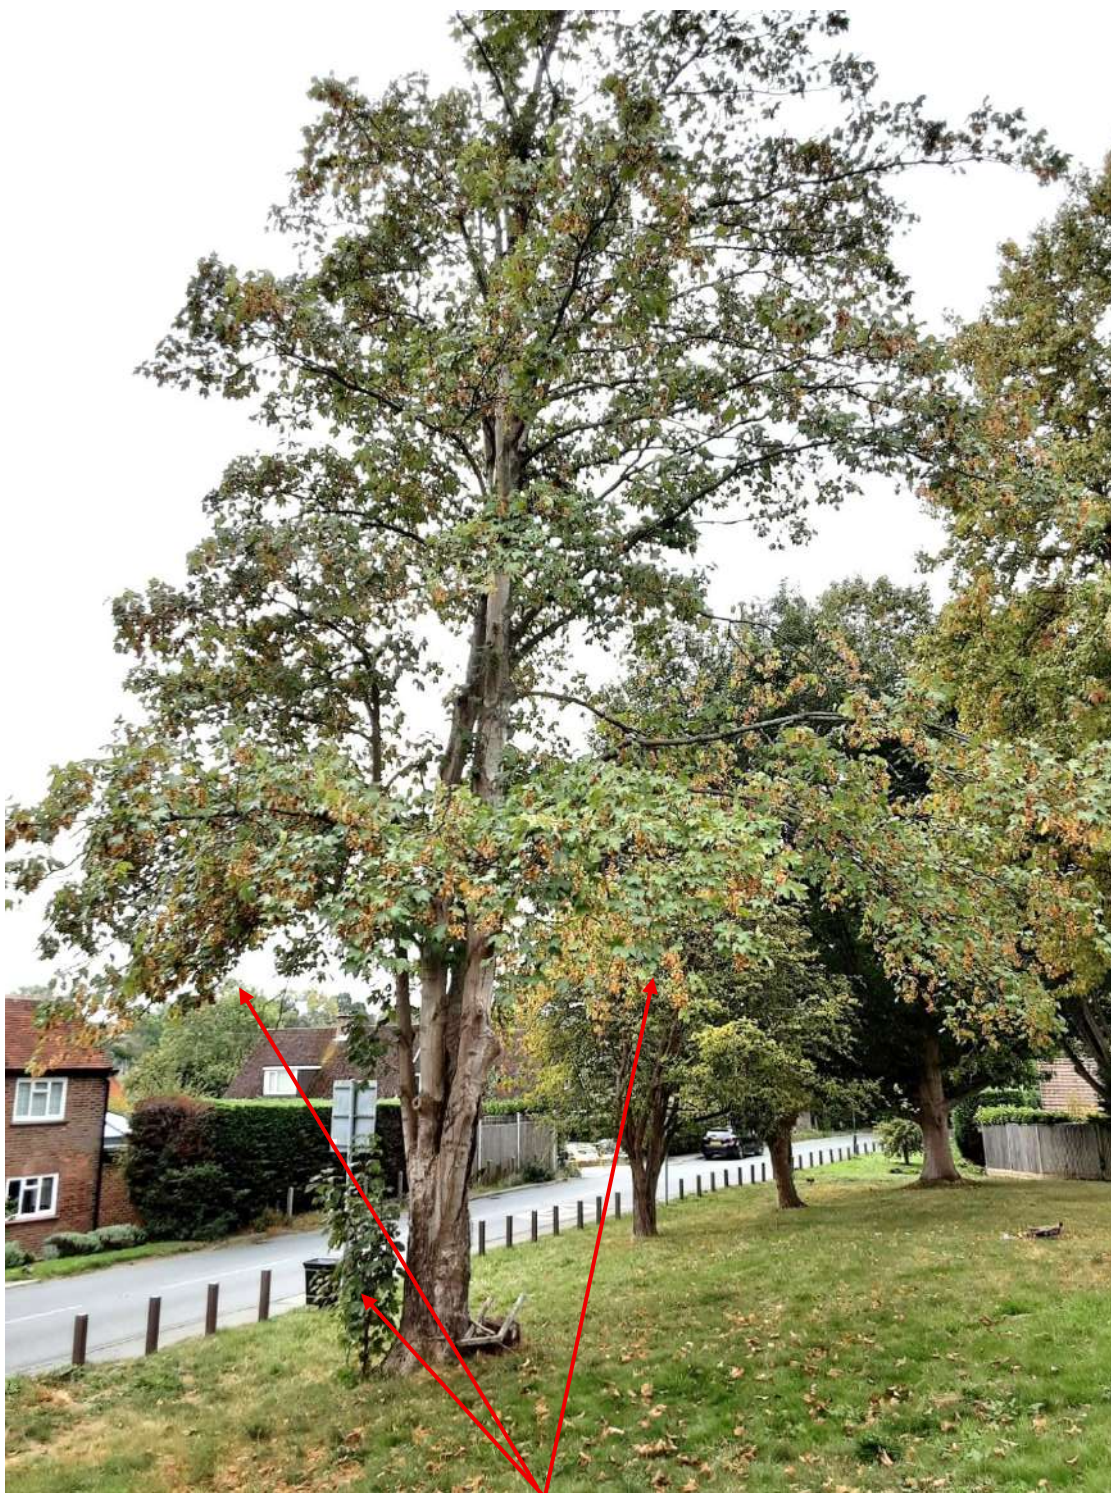
### 0300 – Sycamore

Lower crown and epicormic growth on eastern side of stem base shading ground, impeding development of wild flower meadow.

| Tree Ref | Species | H (m) | Spr (m) | Maturity | Condition | Action Recommendations | Costs | Priority | Done | Inspected |
|---|---|---|---|---|---|---|---|---|---|---|
| 0300 | Sycamore | 15 | 4 | M | Fair | Raise low canopy :: To 6.0m<br>Remove :: Epicormic growths | £166.90<br>£55.65 | 1 year<br>6 Months | No<br>No | 28-Sep-26 |
| Comment: Remove epicormic growth on eastern side of stem base.<br>Crown lift to a height of approximately 6m.<br>(Management works to encourage development of wild flower meadow). | | | | | | | | | | |

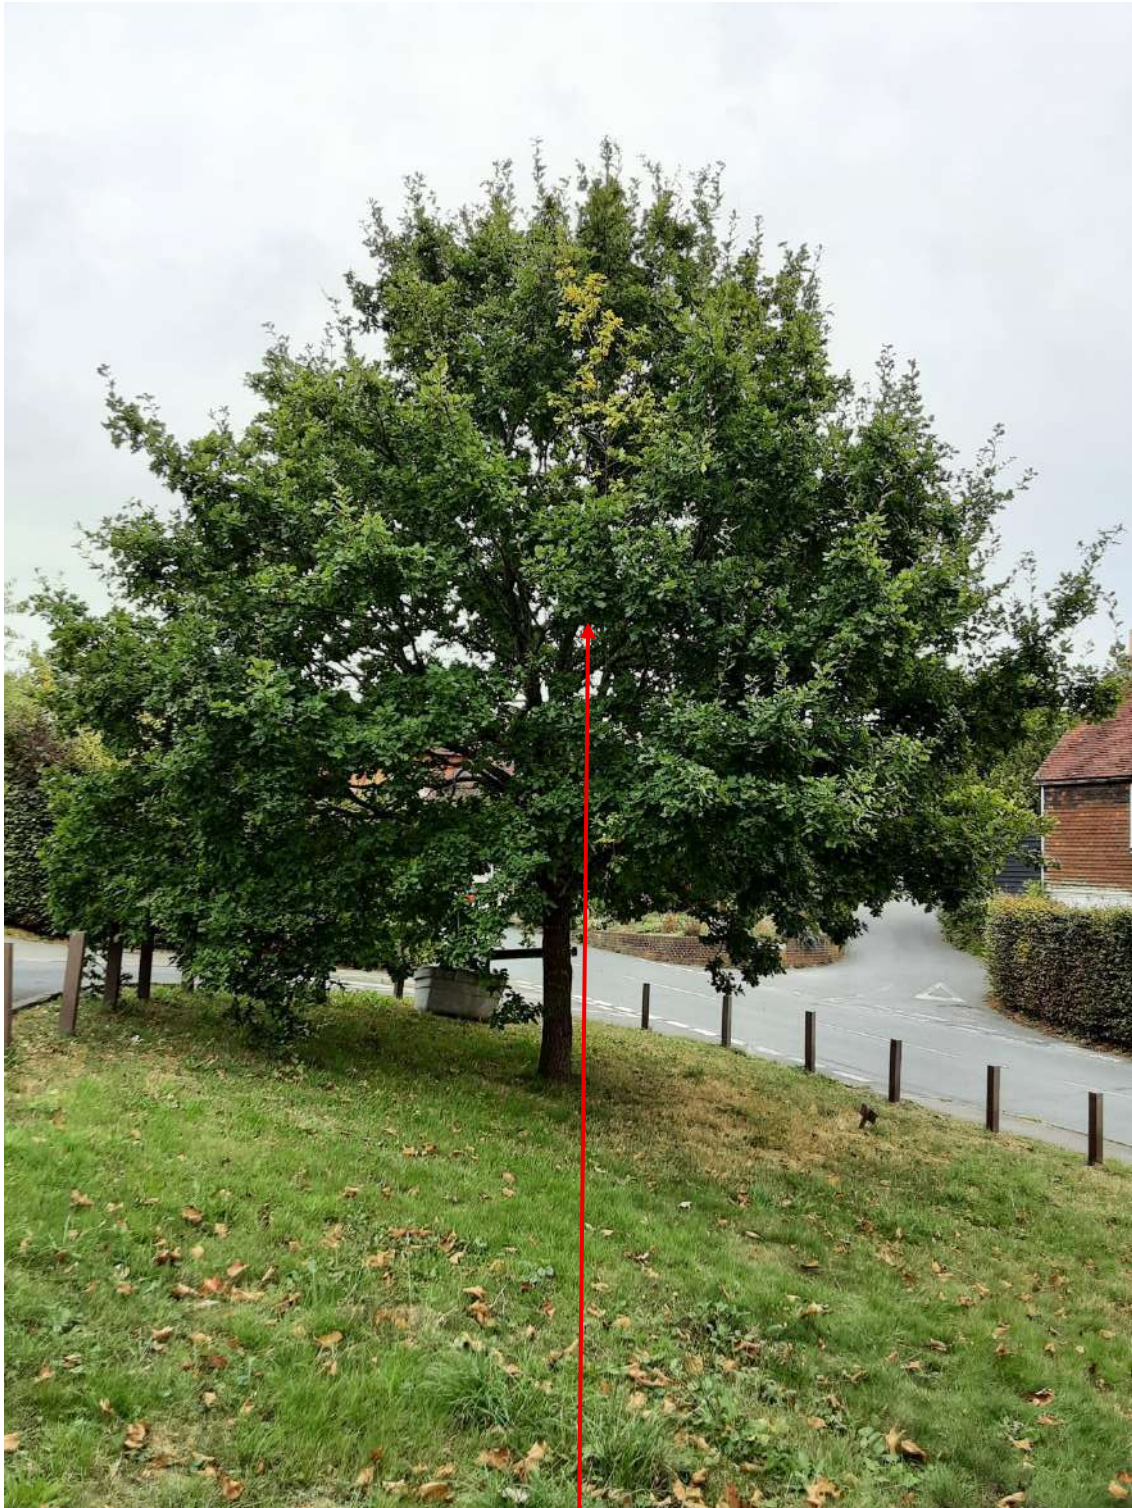
**3194 – Common Oak**

Dense crown shading ground, impeding development of wild flower meadow.

| Tree Ref | Species | H (m) | Spr (m) | Maturity | Condition | Action Recommendations | Costs | Priority | Done | Inspected |
|---|---|---|---|---|---|---|---|---|---|---|
| 3194 | Common Oak | 8.5 | 3 | SM | Good | See Comment :: See Comment | £333.75 | 1 year | No | 28-Sep-26 |
| Comment: Raise canopy to give a clearance of 3m from ground level.<br>Thin crown by 25%.<br>(Management works to encourage development of wild flower meadow). | | | | | | | | | | |

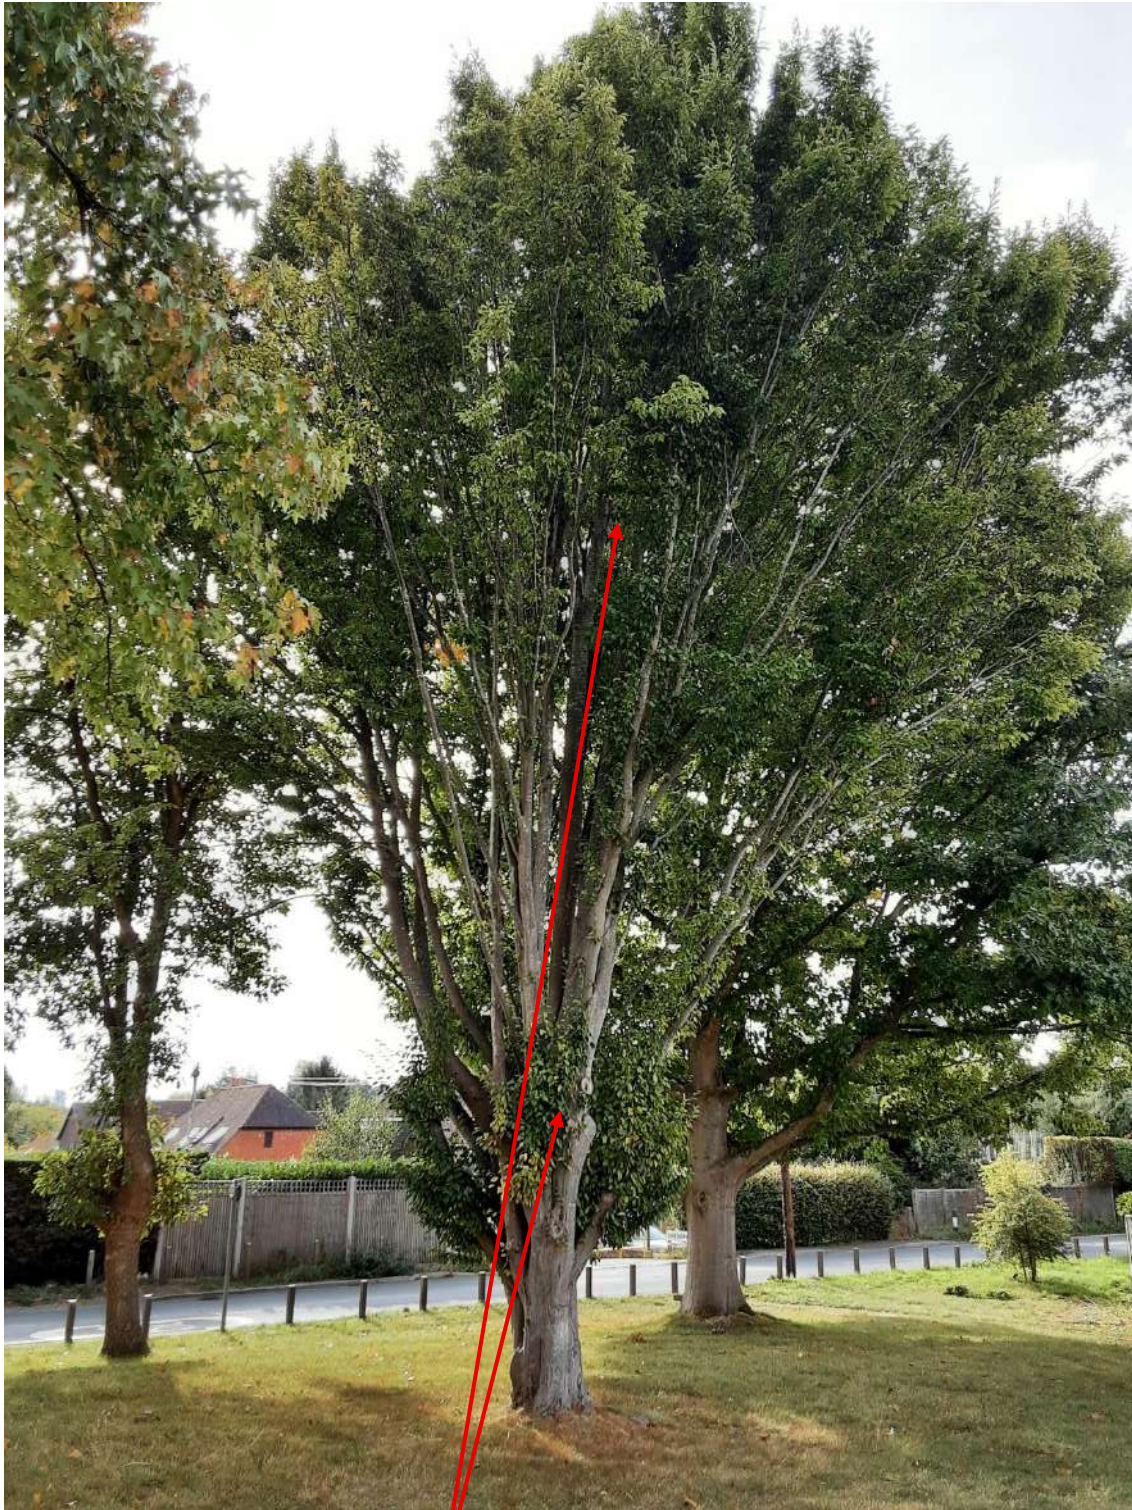
**3195 – Hornbeam ‘Fastigiata’.**

Dense crown and regrowth on pruning wounds on lower stems up to a height of approximately 5m shading ground, impeding development of wild flower meadow.

| Tree Ref | Species | H (m) | Spr (m) | Maturity | Condition | Action Recommendations | Costs | Priority | Done | Inspected |
|---|---|---|---|---|---|---|---|---|---|---|
| 3195 | Hornbeam 'Fastigiata' | 13 | 4 | SM | Fair | Reduce crown(s) :: By 50% | £556.25 | 1 year | No | 28-Sep-26 |
| Comment: Reduce crown by approximately 4.5m (50%).<br>Remove regrowth on pruning wounds on lower stems, up to a height of approximately 5m.<br>(Management works to encourage the development of wild flower meadow). | | | | | | | | | | |

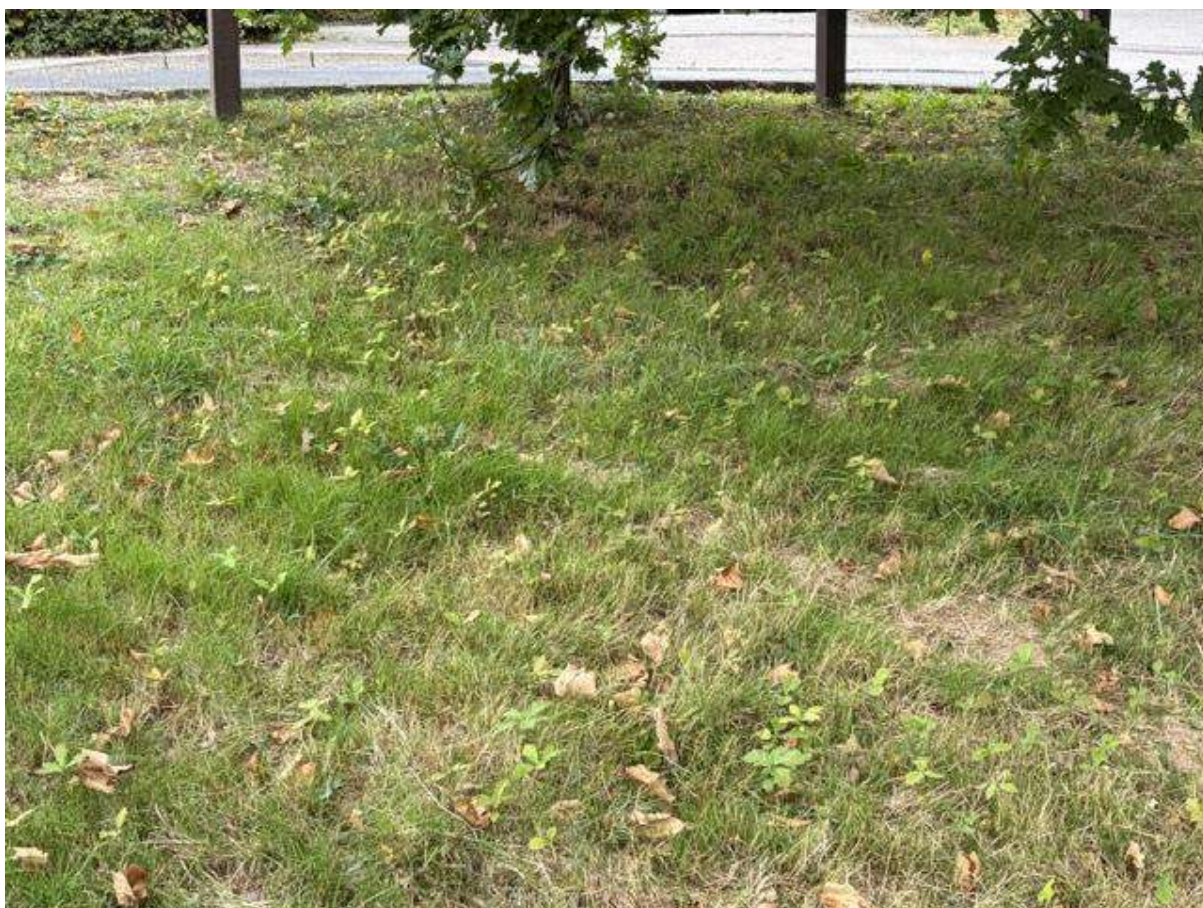
- 2.3.2 There is an area of self-sown oak seedlings under the canopy of tree 3194 Common oak and another area of self-sown hornbeam seedlings (approximately 2m x 2m) in the central area of the open space in between trees 0299 Common hawthorn and 0295 Sweetgum (see attached Photographs). Continued, regular, short mowing of the grass on the open space will inhibit the growth and establishment of these tree seedlings. However, if the future mowing regime on this open space is to be reduced and/or cut at an increased height as part of the management of the wildflower meadow, herbicide spot treatment may be required to control the tree seedlings and prevent completion with any establishing wildflowers. Alternatively, specific areas could be managed as wildflower meadow, rather than the whole of the open space. If neither option is deemed desirable by the Parish Council, it is recommended that another more suitable open site, with no or very few trees, in the Parish is identified for a wildflower meadow.

Self-sown oak seedlings under the canopy of tree 3194 Common oak.

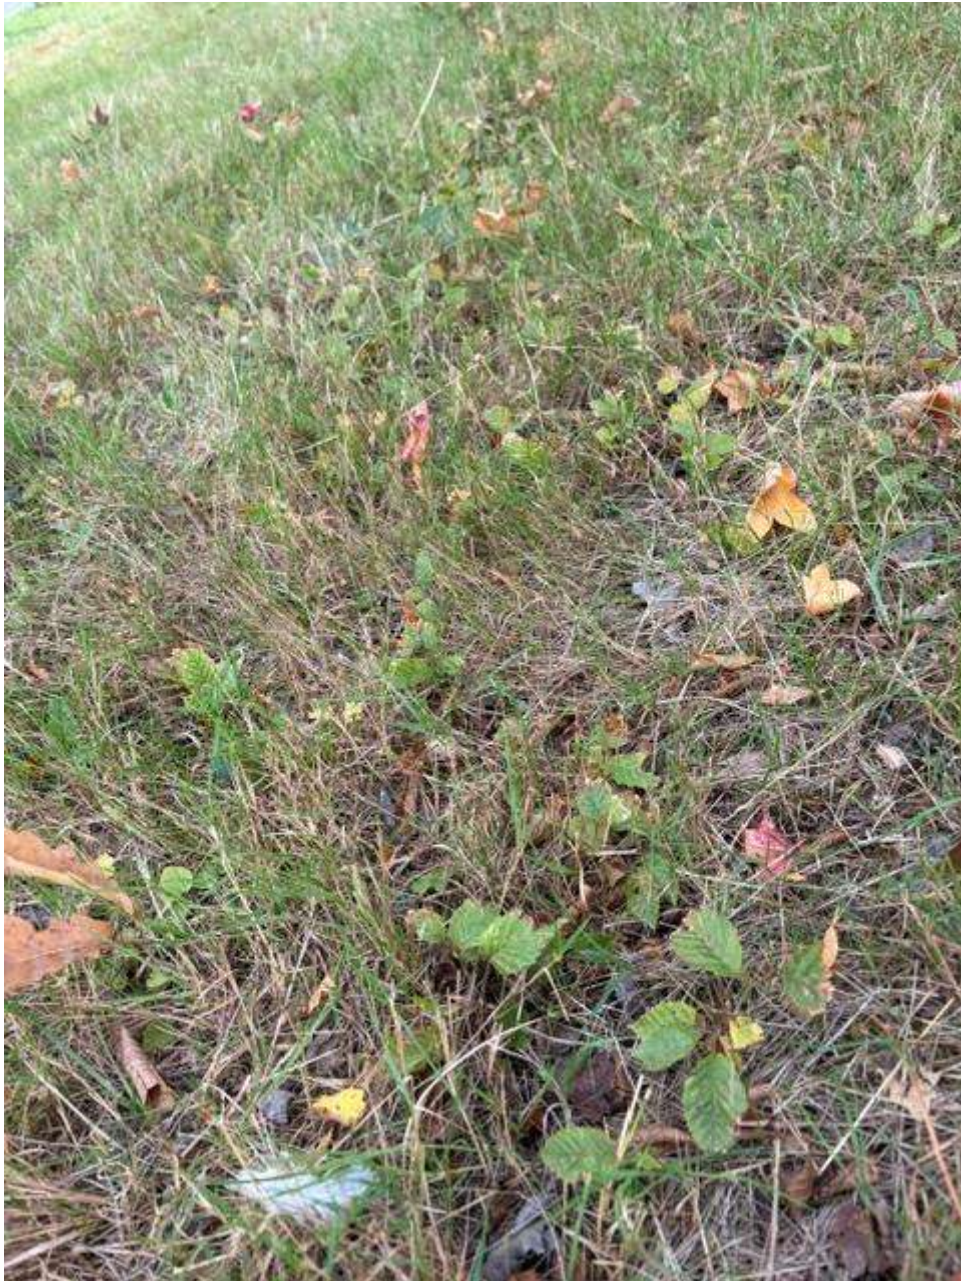
Area of self-sown hornbeam seedlings in the central area of the open space in between trees 0299 Common hawthorn and 0295 Sweetgum.
