Flood Investigation Report

Location of Investigation: Horsmonden

Date of incident: 25 July 2021

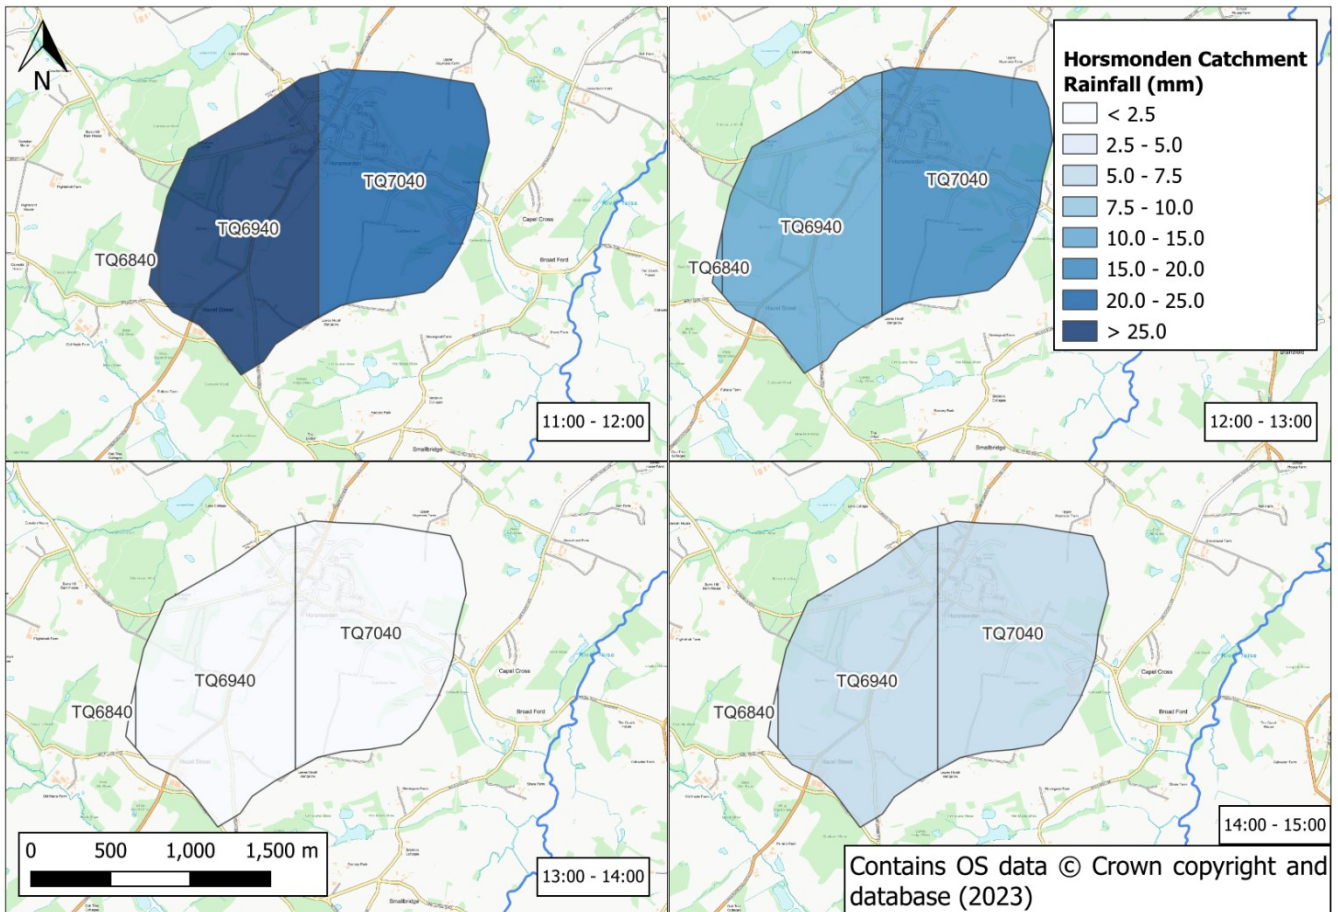
Figure 2 Hourly rainfall radar data from the Met Office from 11:00 - 15:00 across the estimated Horsmonden catchment.

Error! Reference source not found. below shows the recorded rainfall distribution across the main Horsmonden catchment based on the radar data between 11:00 – 15:00. The radar data suggests the storm was more intense to the west of Horsmonden; with some slight indication the storm tracked from west to east, although this is not explicitly clear. Intense localised rainfall was experienced elsewhere in the county and this supports a view that the return periods estimated using the rain gauge and radar data are likely to be inaccurate and indicating an event of lesser severity than experienced in Horsmonden.

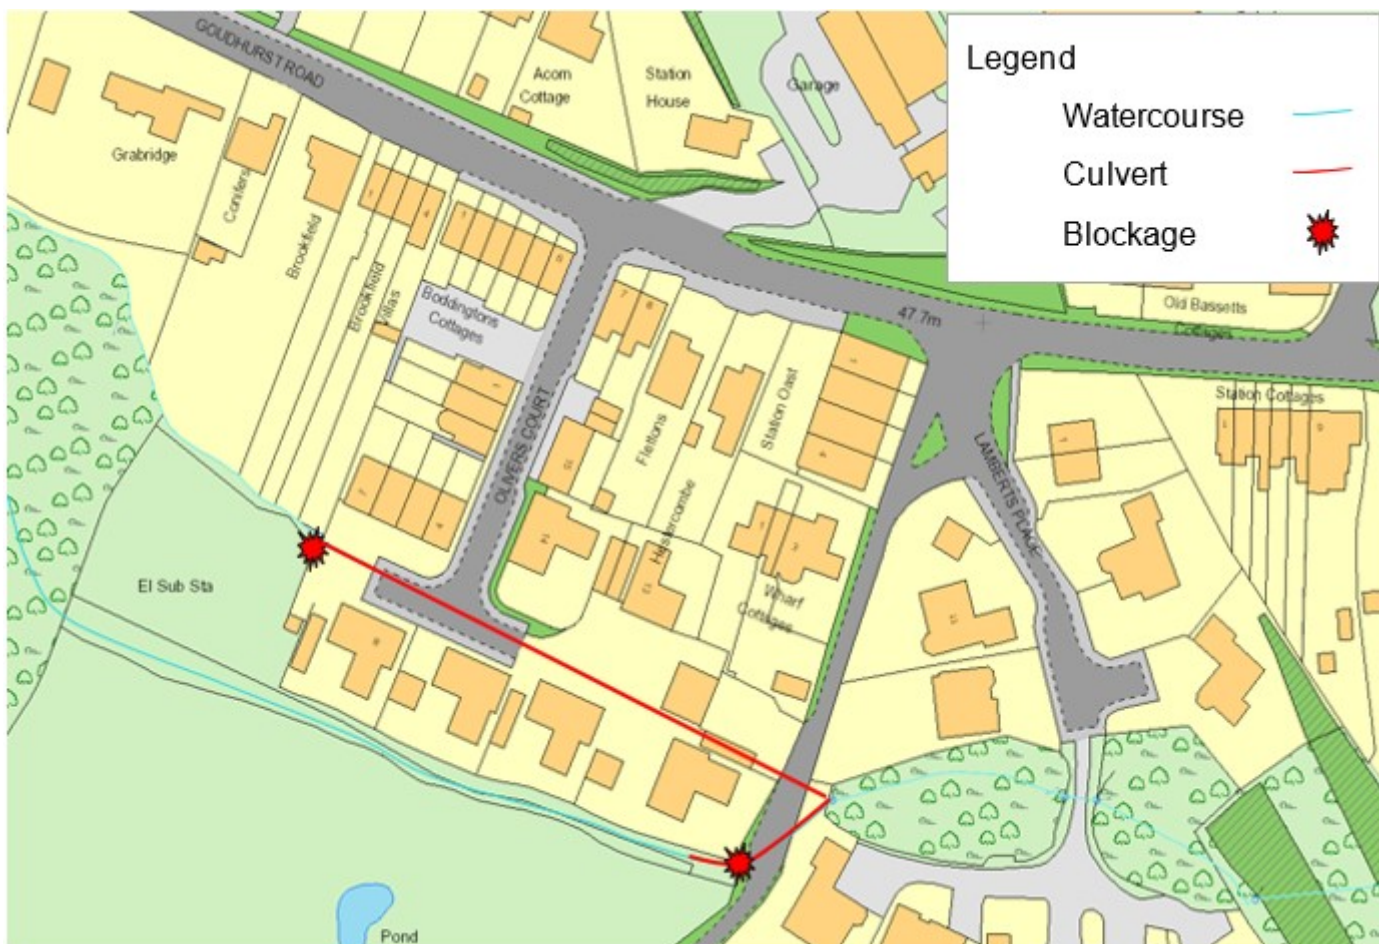
Figure 3 Map showing watercourses and blockages around Olivers Court.

Ordinary watercourses run along the northern and southern boundary of the field west to Olivers Court (Figure 3). The grills covering the inlet to a culvert in the northern watercourse, were blocked with leaf litter and the channels had been maintained. This caused the culvert to become blocked,

and the watercourse backed up and over topped. The southern watercourse had also not been maintained recently and a large log became stuck in the culvert between Olivers Court and Lamberts Place. This caused the watercourse to overtop and flow towards the properties on both Olivers Court and Lamberts Place, once the log was removed by KFRS the flood water began to clear.

The maintenance company, of the land west of Olivers Court, have removed the grills covering the inlet to the northern culvert and have agreed to inspect the watercourses every 6 months.

- Evaluation of the current highway drainage maintenance undertaken in Horsmonden to understand if it is appropriate.
- Communication with local residents regarding local flood risks and consultation regarding actions that the community could undertake in future flood events.
- Consultation with local landowners outlining their riparian responsibilities and best practices regarding land management.
- Further investigation into potential improvement works to the culvert located beneath Lamberhurst Road.
- Investigation into the condition and suitability of the culvert located beneath Olivers Court.

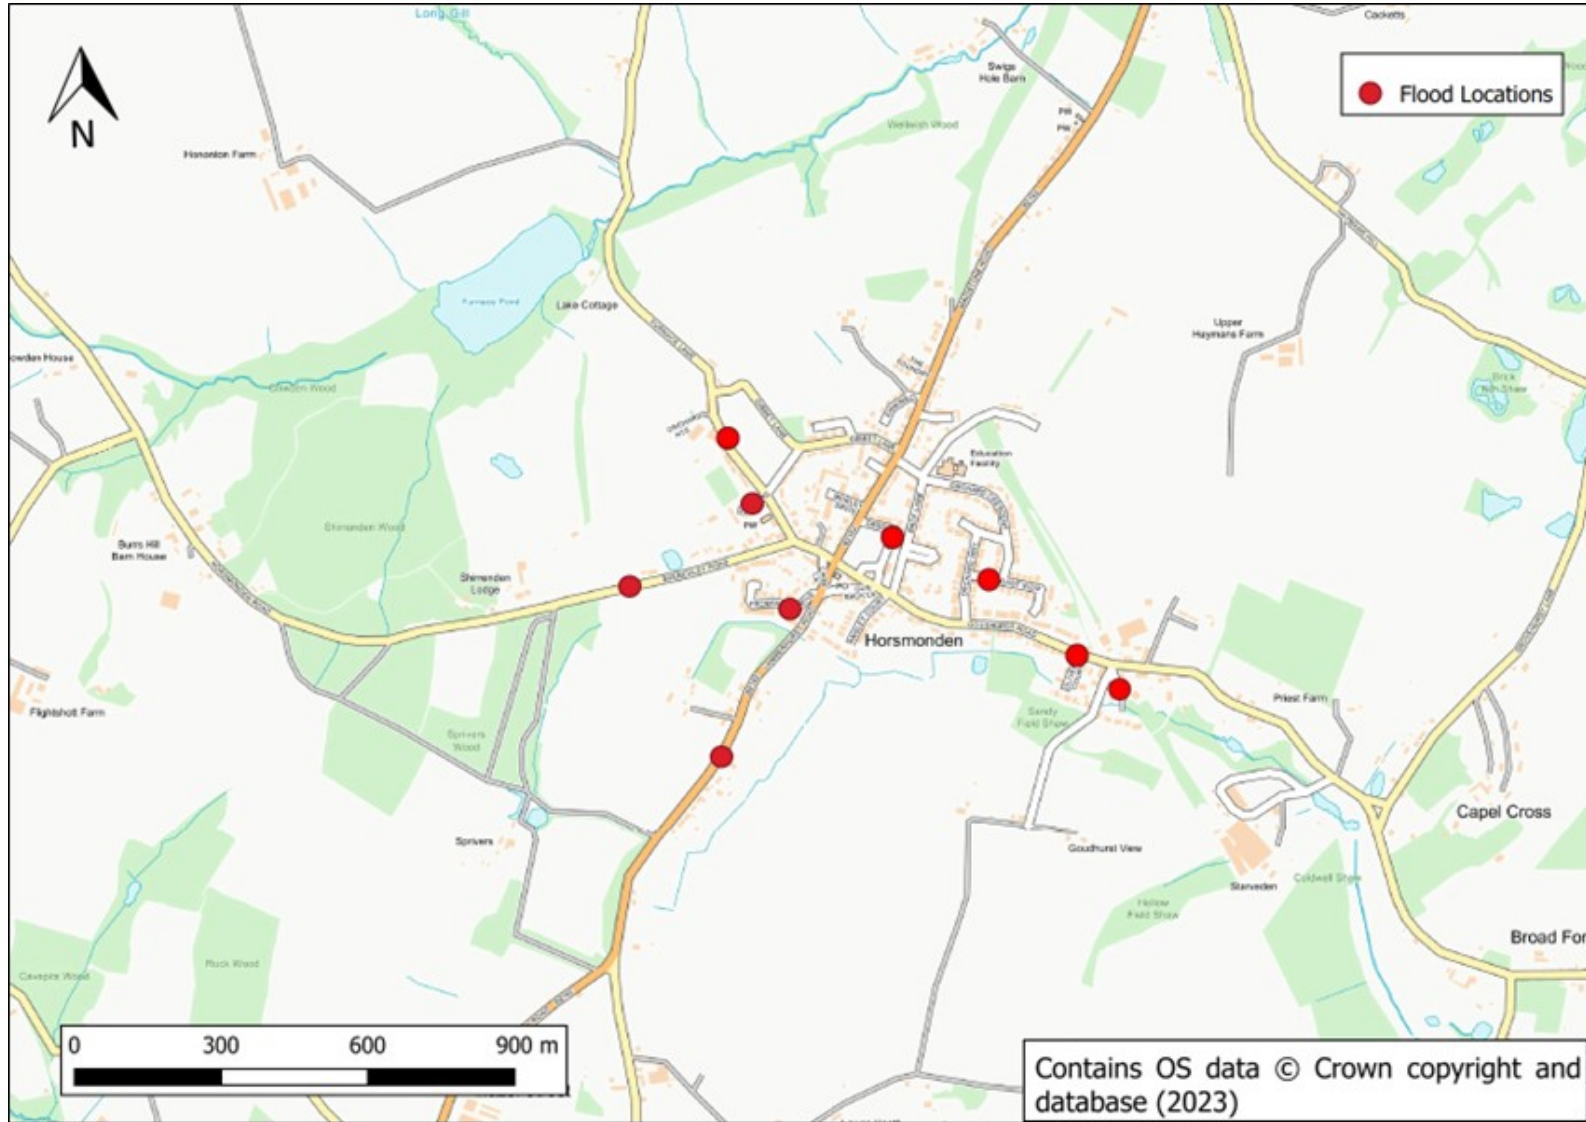
Annex 1 – Location of reported flood incidents in Horsmonden

Approximately 20 properties flooded internally with an additional four properties flooding externally. Due to the intense rainfall, large volumes of surface water runoff flowed from surrounding agricultural land entering the local watercourses causing them and surface water drainage system to become overwhelmed. The approximate locations of the reported flood

incidents are shown in Annex 1, at the end of the report (please note: only the roads where the properties are located have been mapped, and not the individual properties).

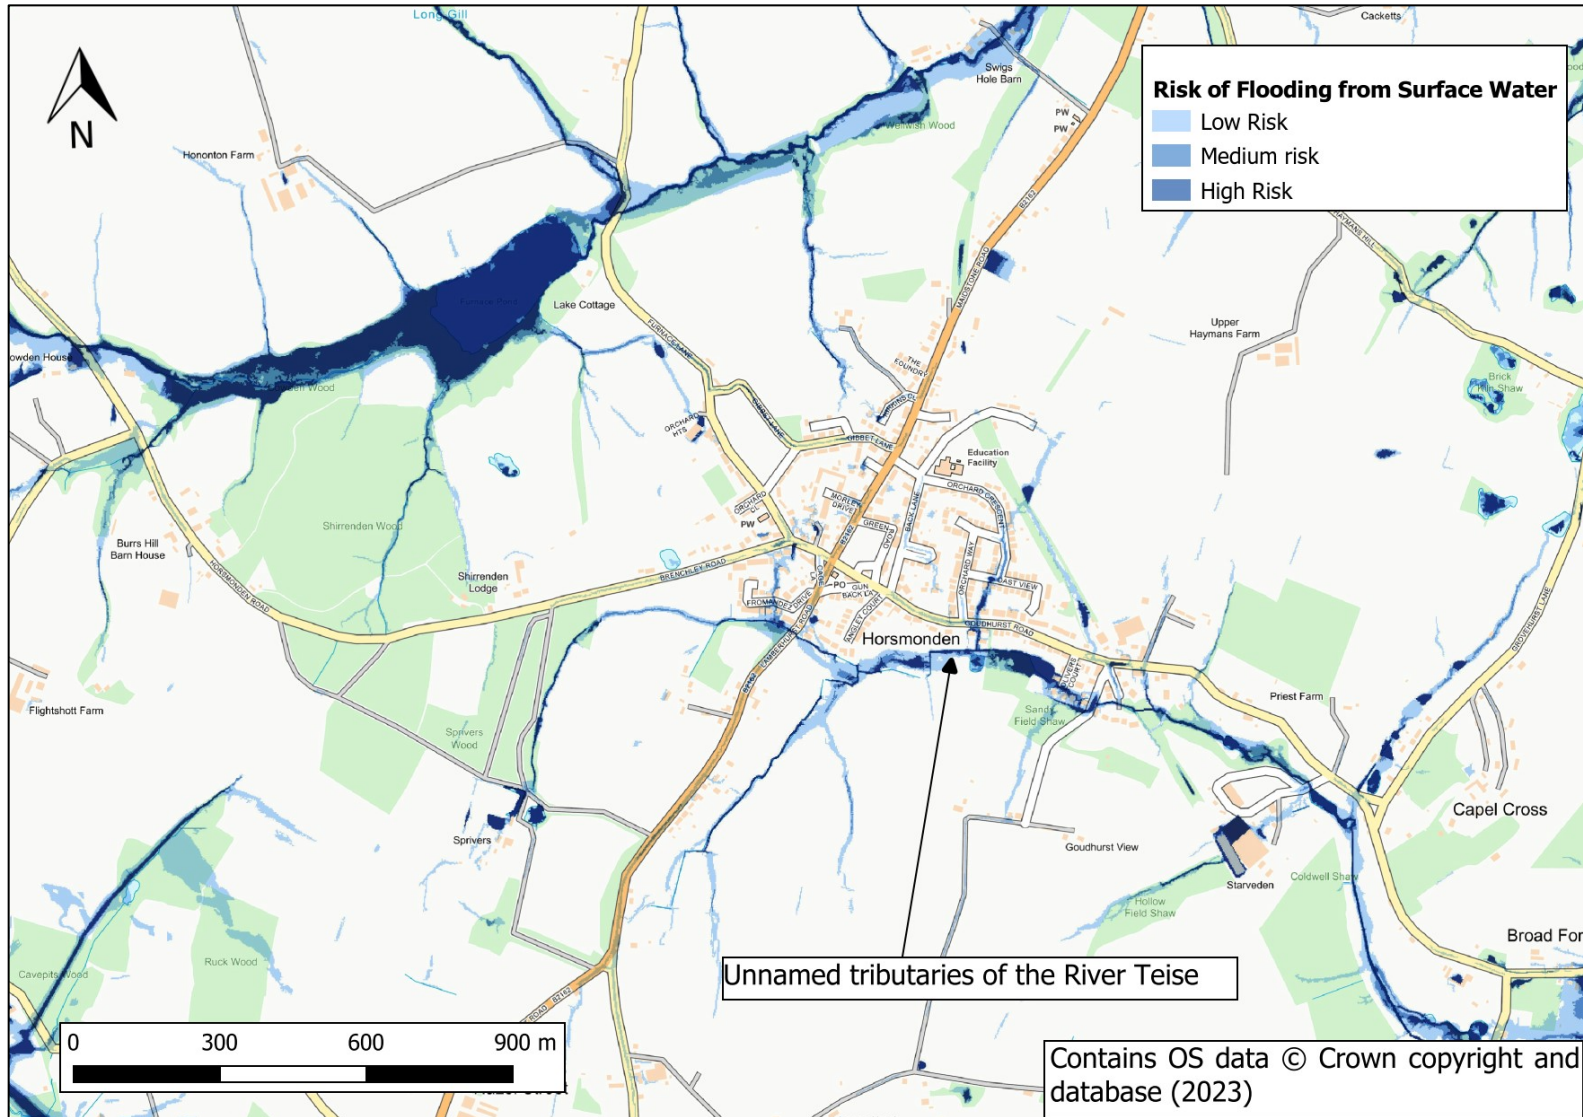
Annex 2 - Extract from the Environment Agency's Flood Risk from Surface Water Map

The Environment Agency's Flood Risk from Surface Water map (Annex 2) indicates that the areas at a high risk of flooding from surface water sources are mainly associated with the unnamed tributaries of the River Teise². Flooding from surface water is typically associated with natural overland flow paths (including the unnamed tributaries of the River Teise) and local depressions in topography where surface water runoff can accumulate during or following heavy rainfall events. The areas indicated to be a high risk of flooding from surface water sources are relatively consistent with the locations of reported properties affected by the flood event.
